Pavement Management Report 2015

PAVEMENT MANAGEMENT REPORT 2015

This report presents an annual summary (fiscal year) of the Riverside County pavement management system and provides pavement condition data of the County’s roadway system. It provides an explanation of the importance of having a pavement management system that guides and supports the County in determining pavement needs and priorities within the funding budget. It further describes certain critical key points as far as understanding pavement life cycle and its ranking approach in implementing cost-effective strategies such as the use of pavement preservation through preventive maintenance on roads in good condition.

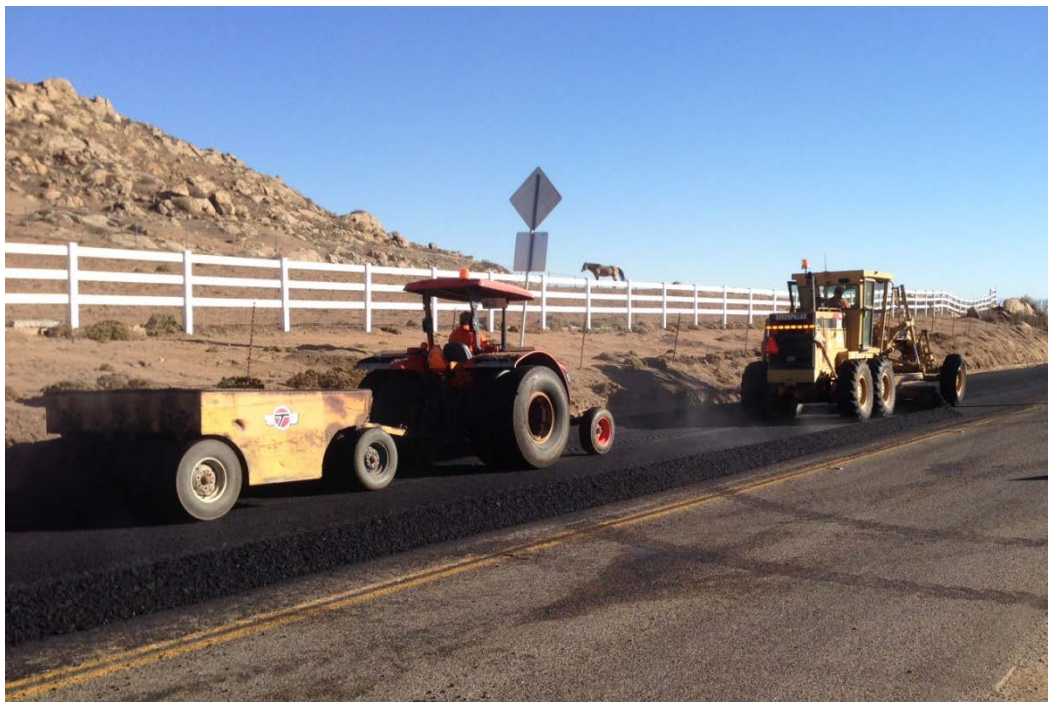
**PLANTMIX OVERLAY BY COUNTY PAVING CREW
SPREADING & ROLLING WITH PULL-BEHIND ROLLER**

PIGEON PASS – WINTER 2014

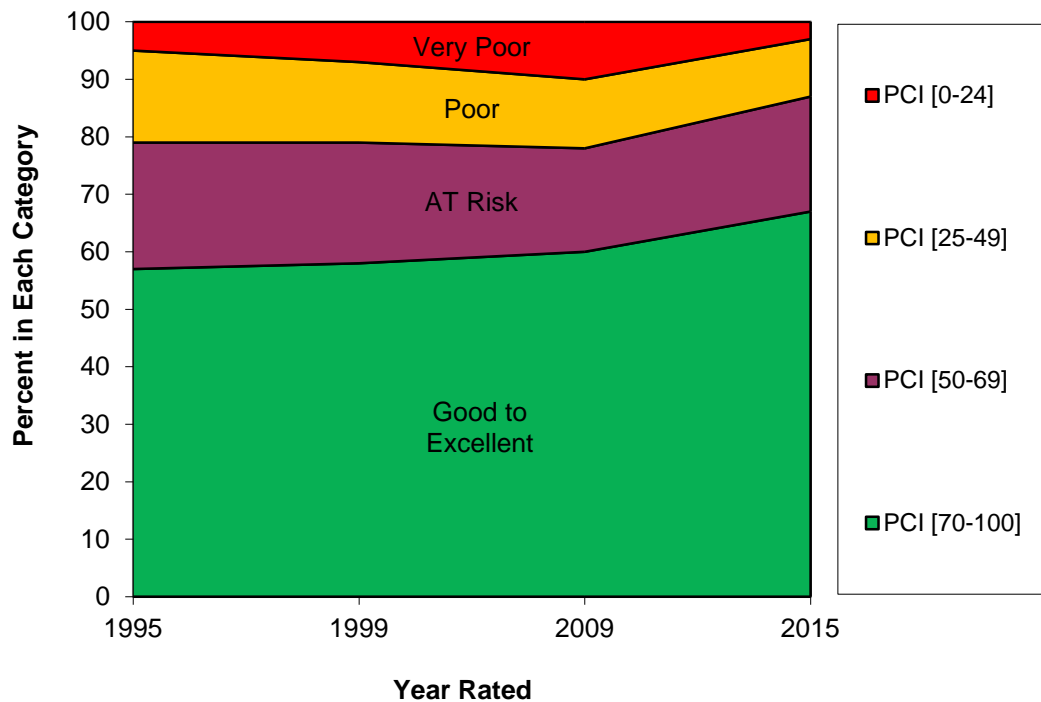
Figure 1. Pavement Condition Trendline (Countywide)

The percentage of mileage categorized by condition rating (good to excellent, at risk, poor, and very poor) over the last 20 years is summarized in Table 3. This table is also presented graphically showing the pavement condition trend in Figure 1 below.

¹⁾ Distressed roads include roads from the AT RISK, POOR, and VERY POOR categories. Over the last 20 years, the percentage of distressed roads has been gradually declining from 43% to 33%.

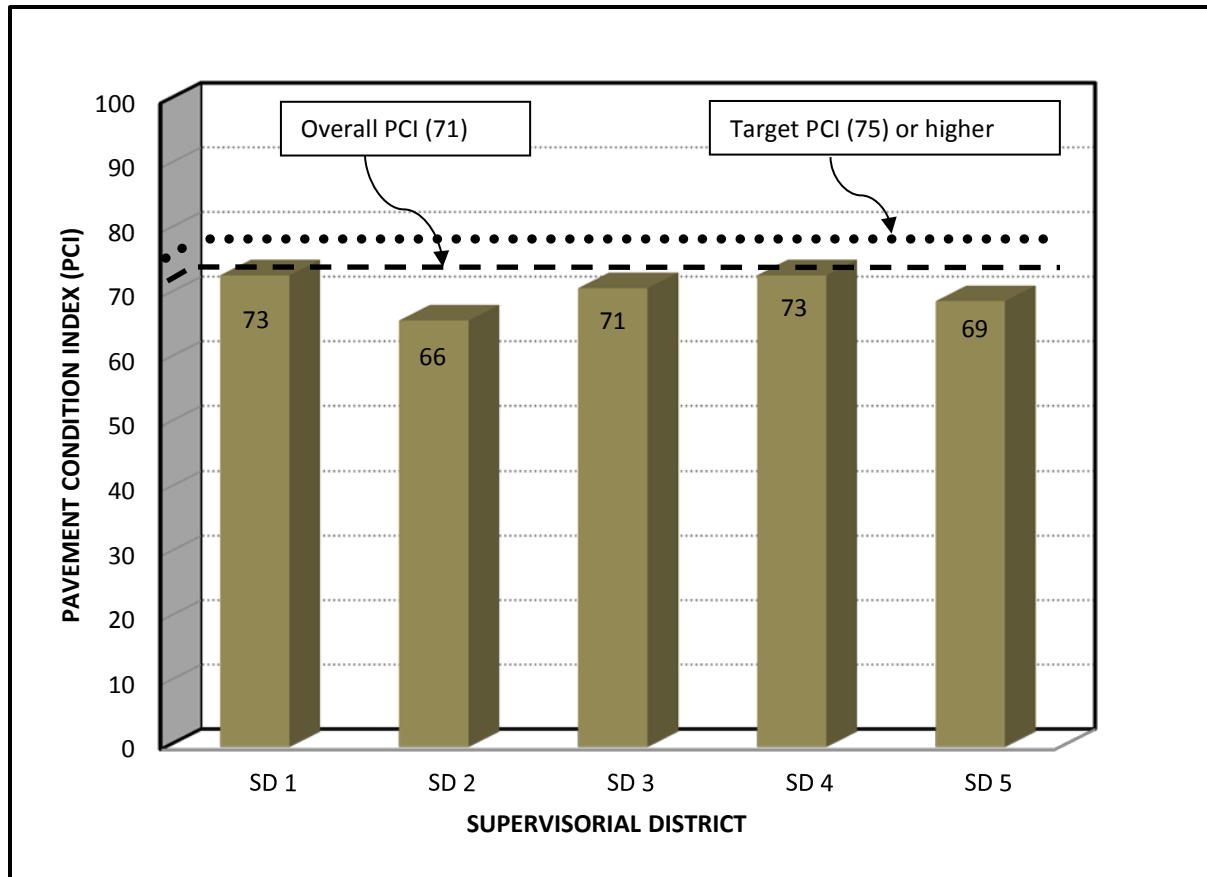
Figure 2. Pavement Condition Index by Supervisorial District

The Target PCI of 75 or higher, as shown in Figure 2, is based on a set goal that all pavements throughout the County road network system need to reach a condition where Best Management Practices (BMP) can occur. This means that only the most cost-effective pavement preservation treatments are needed, such as, chip seal, slurry seal, cape seal, and thin overlay. Reaching and maintaining the target PCI offers other benefits (other than cost) such as reduced impact to the public in terms of:

As noted on the chart in Figure 2, the overall PCI of 71 is considered “Good” by definition of PCI shown in Figure 10 (page 1), “Relationship between PCI and Condition,” of this report. From the generalized pavement deterioration curve shown in Figure 12 (page 5), “Pavement Deterioration Curve,” of this report, a PCI below 70 signifies a pavement at risk. The roadway network’s life and deterioration accelerates rather rapidly at a PCI between 50 and 69 and if repairs are delayed by just a few years, preventative maintenance could increase the cost of the treatment significantly, as much as ten times.

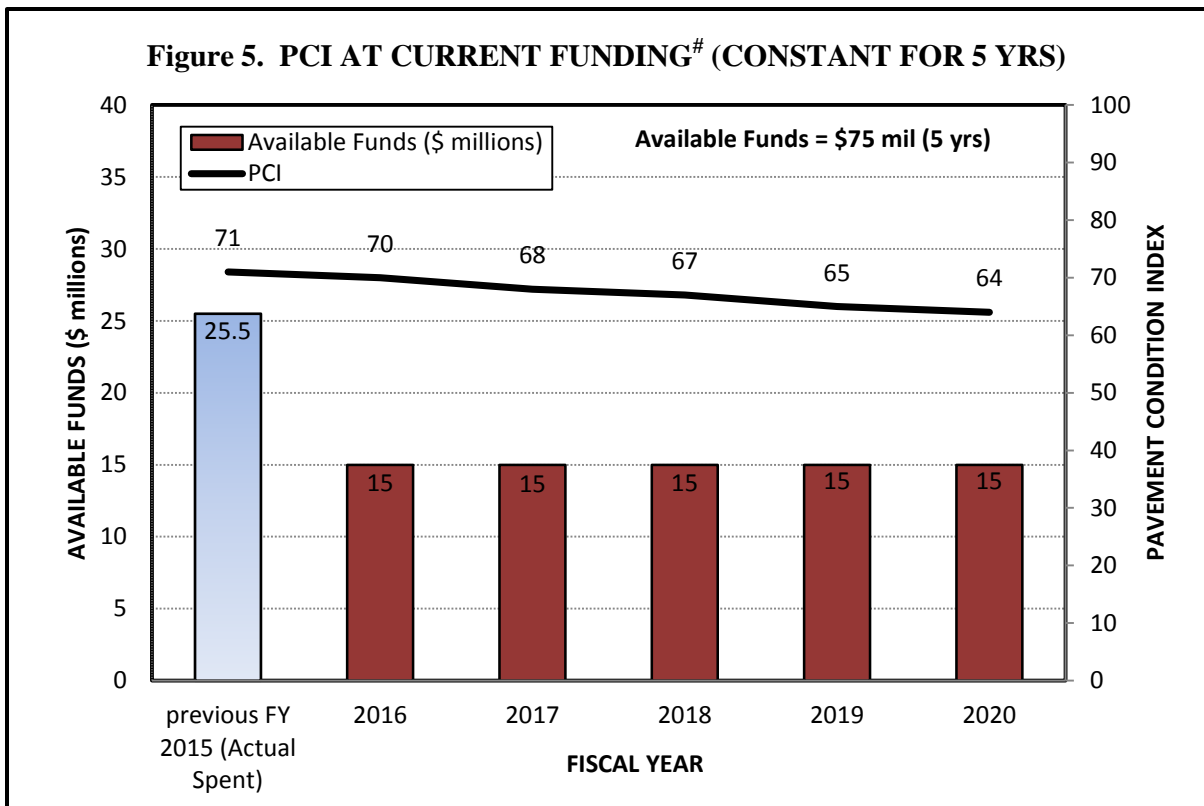
[#] denotes current funding is reduced to \$15 million/year (from \$20 million/year as reported from previous reports).

As illustrated by the funding scenario in Figure 5, maintaining the current funding of \$15 million annually for the next 5 years will have an impact on the PCI of the road network. Initially for the first year, the PCI will be 71 starting in 2016 then gradually declining to 64 over a 5-year period. The previous fiscal year (2015) is shown for the actual money spent in maintaining the PCI of 71.

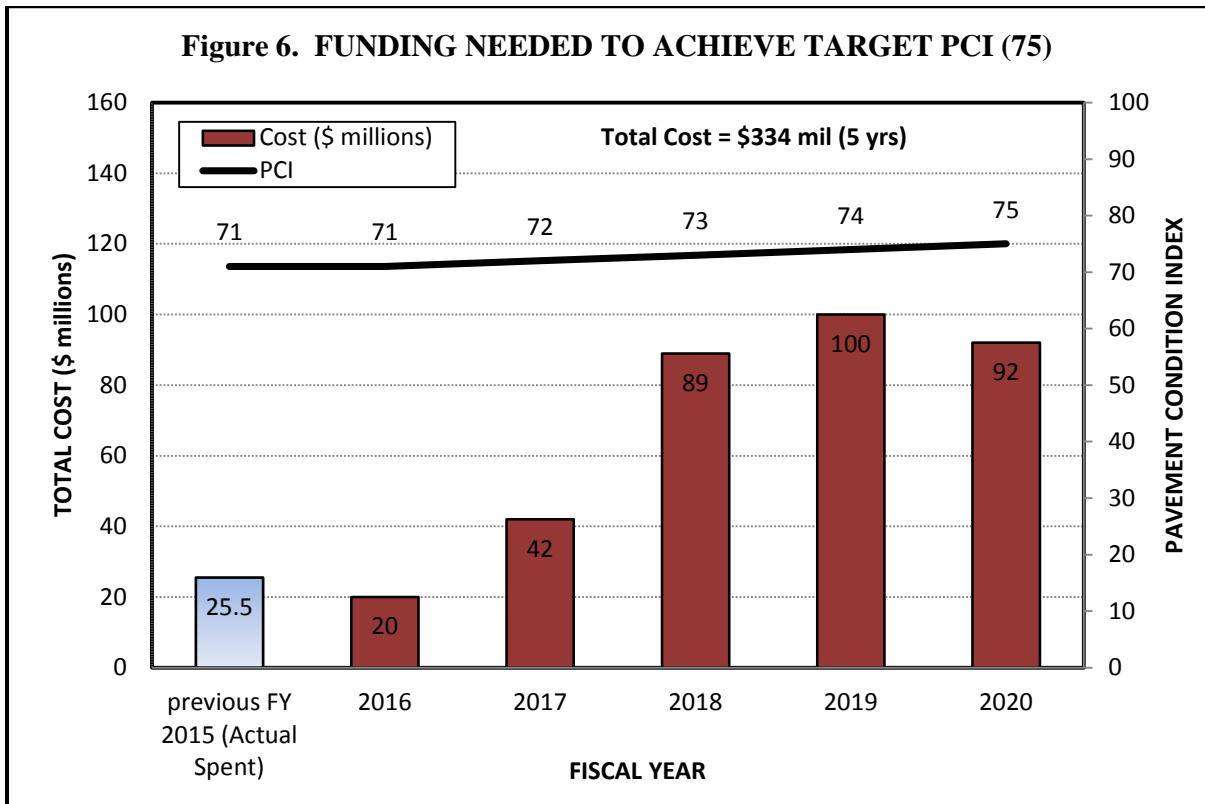
Given the two funding scenarios illustrated in Figure 5 and Figure 6 for the needs and available cash, the funding shortfall can be calculated. For each scenario, the total cost or available cash is simply the sum of each cost or available cash per year for 5 years. As depicted in Table 4, the shortfall is \$259 million. Clearly, the available funding is inadequate in meeting the BMP goal within the period analyzed. Based on the results of this analysis, approximately \$259 million of additional funding is needed to bring the pavement condition of the county roads to an overall PCI of 75.

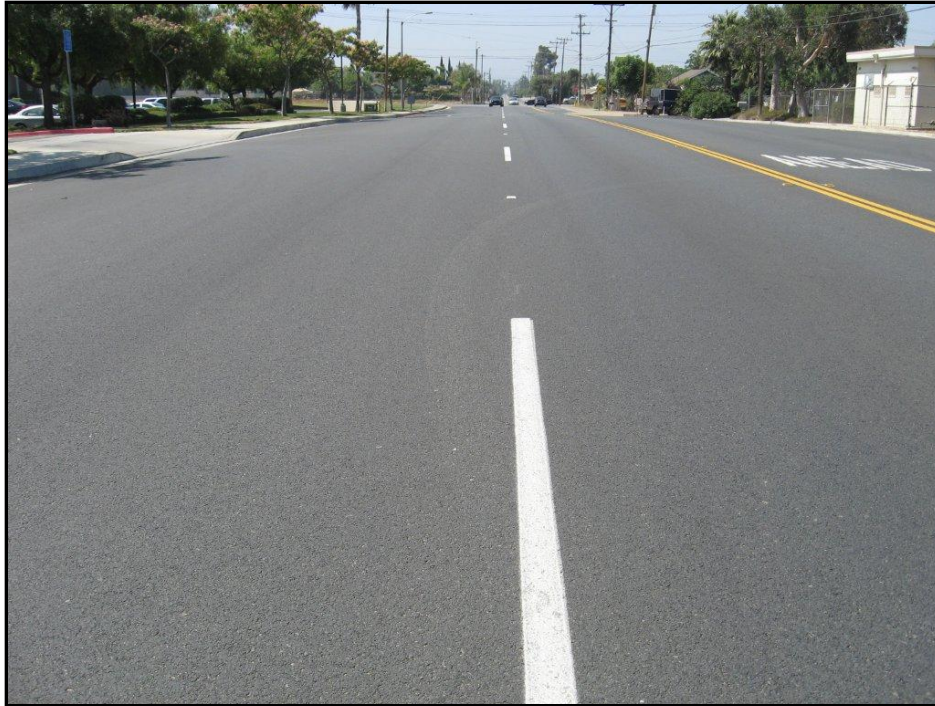
Figure 11A. PCI=98 (Excellent Condition)

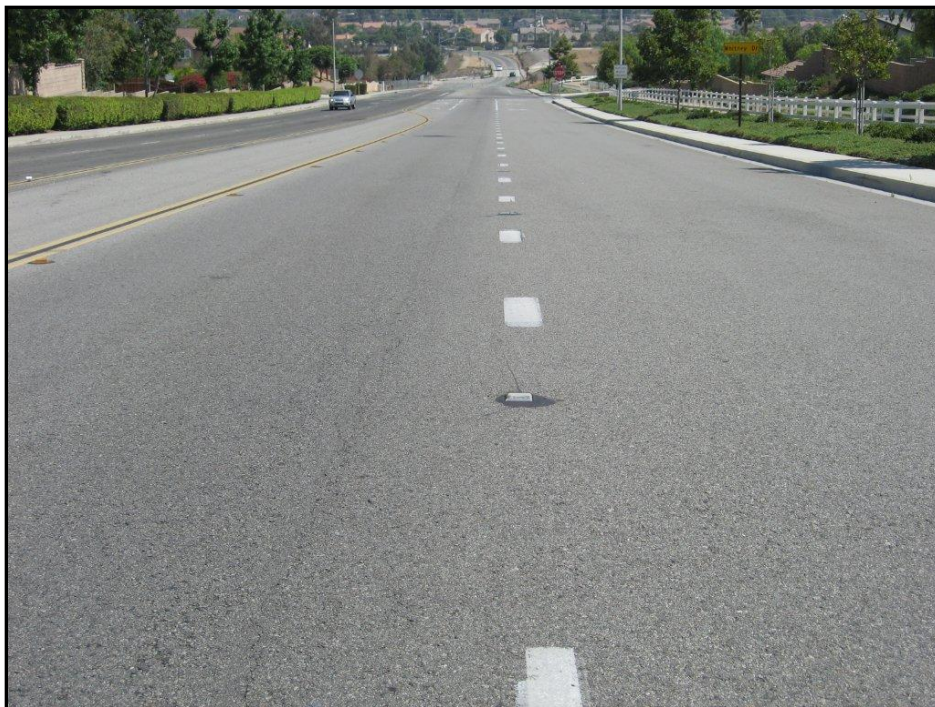
Figure 11B. PCI=85 (Very Good Condition)

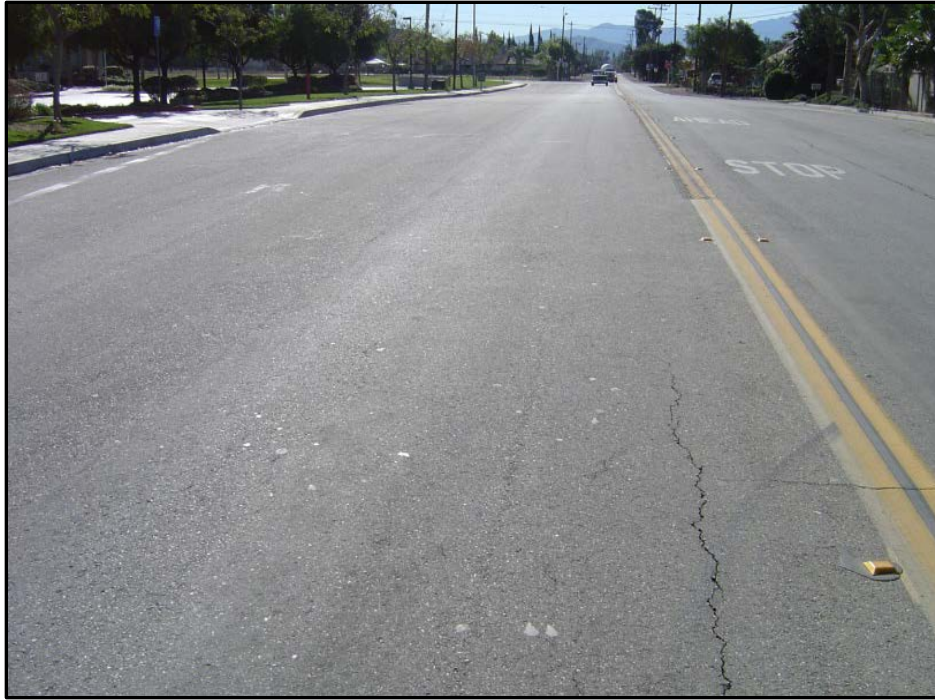
Figure 11C. PCI=78 (Good Condition)

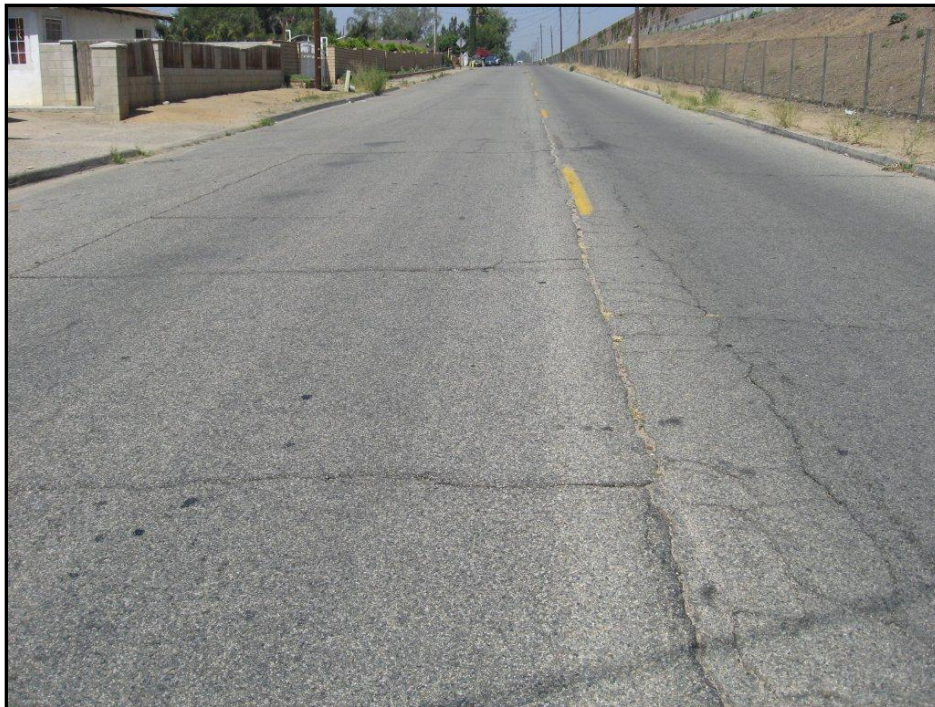
Figure 11D. PCI=56 (At Risk Condition)

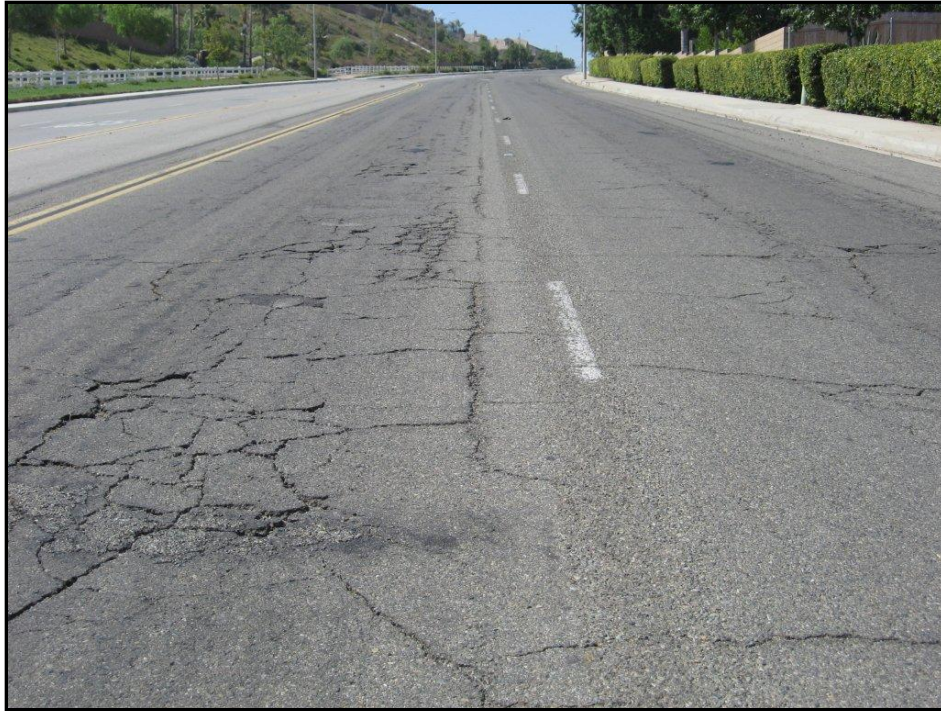
Figure 11E. PCI=30 (Poor Condition)

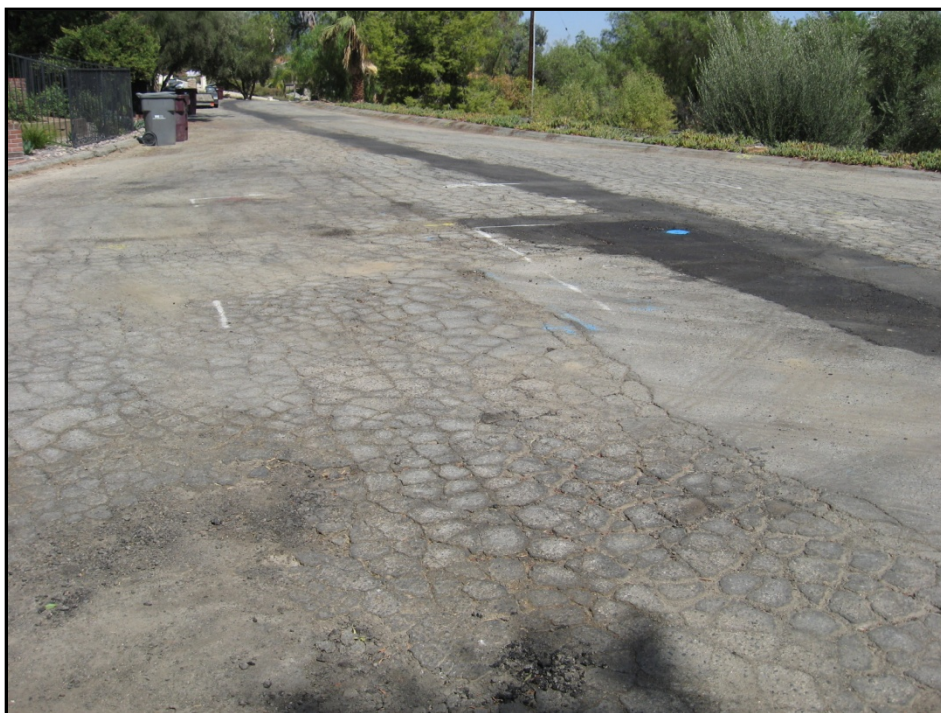
Figure 11F. PCI<10 (Very Poor Condition)

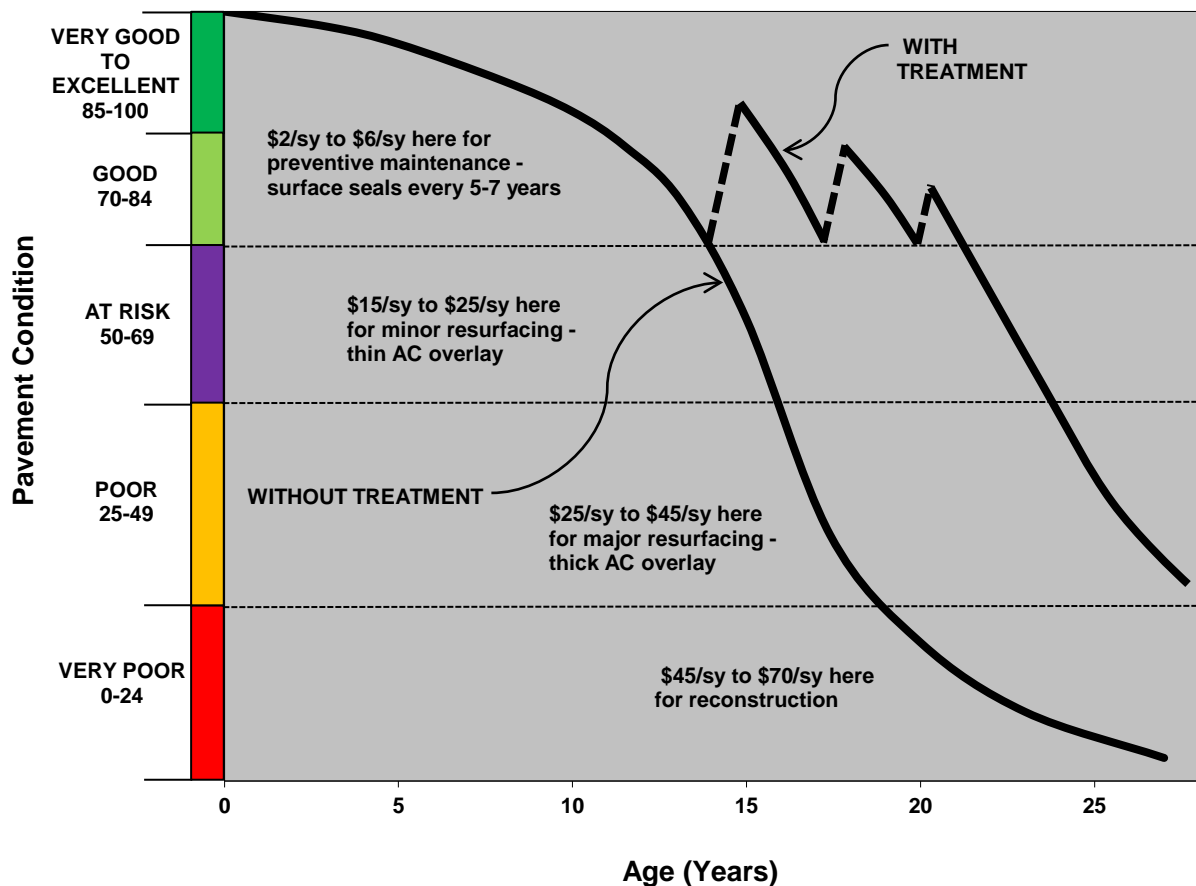
Figure 13. Pavement Deterioration Curve With and Without Treatment

An effective pavement preservation program will treat pavements while they are still in good condition and prior to the need for major reconstruction work. By applying a cost-effective treatment at the right time, the pavement is restored almost to its original condition. Figure 13 illustrates the concept of pavement preservation as it relates to enhancing pavement performance, extending pavement life, and ensuring taxpayer dollars are utilized wisely while providing improved safety and mobility to the public.

As depicted in Figure 13, the cumulative effect of systematic, successive preservation treatments is the postponement of costly resurfacing and reconstruction. During the life of a pavement, the cumulative discount value of the series of pavement preservation treatments is substantially less than the discounted value of the more extensive, higher cost of reconstruction and generally more economical than the cost of major resurfacing.

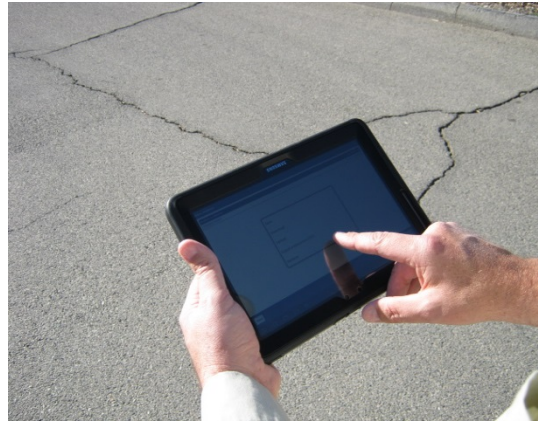
Inspection of pavement conditions is performed every year on one-fourth of the County's pavement network, which places all roads on a four-year inspection cycle. A field inspection or visual inspection survey is conducted by pavement raters (two-man crew) who walk each individual road segment evaluating the pavement for signs of distresses. In early 2012, the County switched its data collection approach from paper inspection sheets to a hand-held computer device, as depicted in Figure 15. Not only does a hand-held device accelerate the collection of pavement distress data, but it also reduces paper usage - an environmentally friendly methodology.

Figure 15. Tablet device use in road inspection.

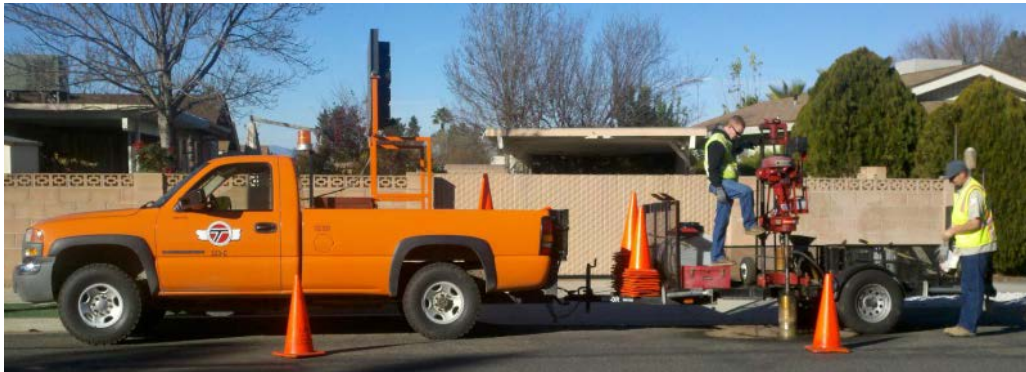
The County invests millions of dollars each year in pavement maintenance activities. Records of performance of the pavement maintenance treatments placed during these activities are crucial in order to determine which treatment alternative is the best option to use. With advancements in data collection practices and equipment, the County invested in a Ground Penetrating Radar (GPR) and a Falling Weight Deflectometer (FWD) in addition to its already established data collection methodology of using coring and visual inspection survey. Figure 17 and Figure 18 depict the road data collection equipment.

Figure 17. County's Coring Rig

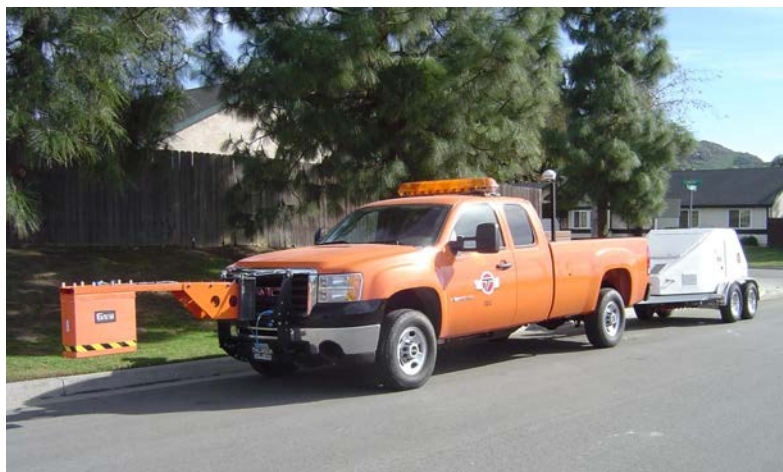
The GPR is used to measure pavement layer thickness and detect groundwater or voids beneath the pavement. The FWD characterizes pavement structural condition. Data collected from this state of the art equipment provide new information that can be used to improve pavement management recommendations as well as support the County's pavement rehabilitation and design activities.

Figure 18. FWD and GPR Data Collection Equipment

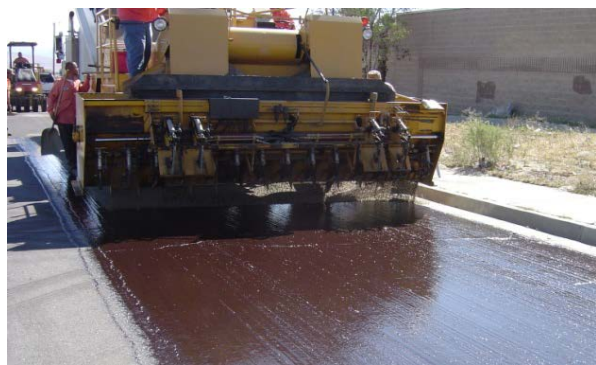
A chip seal is a surface treatment applied to pavement with minimal surface distress to provide a new wearing surface, extend pavement life, and delay major rehabilitation or reconstruction. It is a process in which an asphalt emulsion is sprayed on the pavement then immediately covered by aggregate. Figure 19 illustrates the spreading of aggregate over the sprayed emulsion. When the asphalt emulsion is applied to the road surface in conjunction with a mechanized scrub broom (that forces the emulsion into the cracks), this process is called "scrub seal."

Figure 19. Spreading of chip over emulsion.

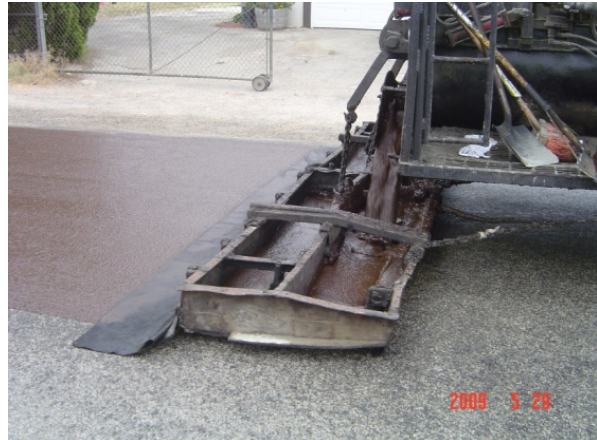
A slurry seal is a maintenance treatment applied to pavement to improve the functional characteristics of the pavement surface. It is a mixture of asphalt emulsion, aggregates and mineral fillers, which is mixed and placed in a continuous basis using a truck mixer. Prior to application, any surface distresses, such as cracks, are filled and sealed. After thoroughly mixing the emulsion, aggregates and mineral fillers in the slurry truck's built-in pug mill, the slurry mixture is poured into a spreader box. As the truck moves forward, the slurry is extruded from the backside of the spreader box, see Figure 20. The box is capable of spreading the slurry over the width of a traffic lane in a single pass resulting in a uniform application. The slurry cures as the water evaporates and turns the freshly placed brown slurry into black slurry. Traffic can be returned once the slurry has cured, which is usually four to six hours.

Figure 20. Spreading of slurry.
