**COUNTY OF RIVERSIDE
TRANSPORTATION DEPARTMENT**

PAVEMENT MANAGEMENT REPORT

PAVEMENT MANAGEMENT REPORT 2016

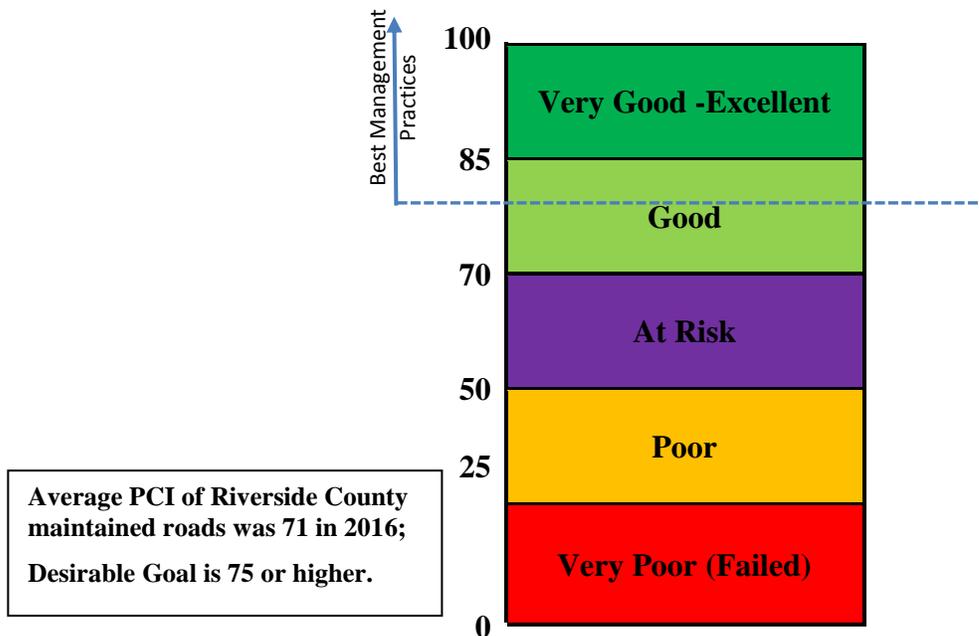
Figure 1. Relationship Between PCI and Condition

In the MTC StreetSaver software, the pavement condition assessment is based on collecting data to determine the type, amount, and severity of surface distress for each segment of pavement being managed. The distress data is used to calculate a Pavement Condition Index (PCI), which is based on a visual survey of the pavement and a numerical index between 0 and 100, with 0 being defined as failed roadway and 100 representing an excellent pavement (newly paved). Figure 1 shows the relationship between the PCI and pavement condition. Photos showing examples of pavement in excellent through very poor condition are shown in Figure 2A through 2F.

As noted on the chart in Figure 5, the overall PCI of 71 is considered “Good” or near “At Risk” by definition of PCI shown in Figure 1 (page 1), “Relationship between PCI and Condition,” of this report. From the generalized pavement deterioration curve shown in Figure 3 (page 5), “Pavement Deterioration Curve,” of this report, a PCI below 70 signifies a pavement at risk. The roadway network’s life and deterioration accelerates rather rapidly at a PCI between 50 and 69 and if repairs are delayed by just a few years, preventative maintenance could increase the cost of the treatment significantly, as much as ten times.

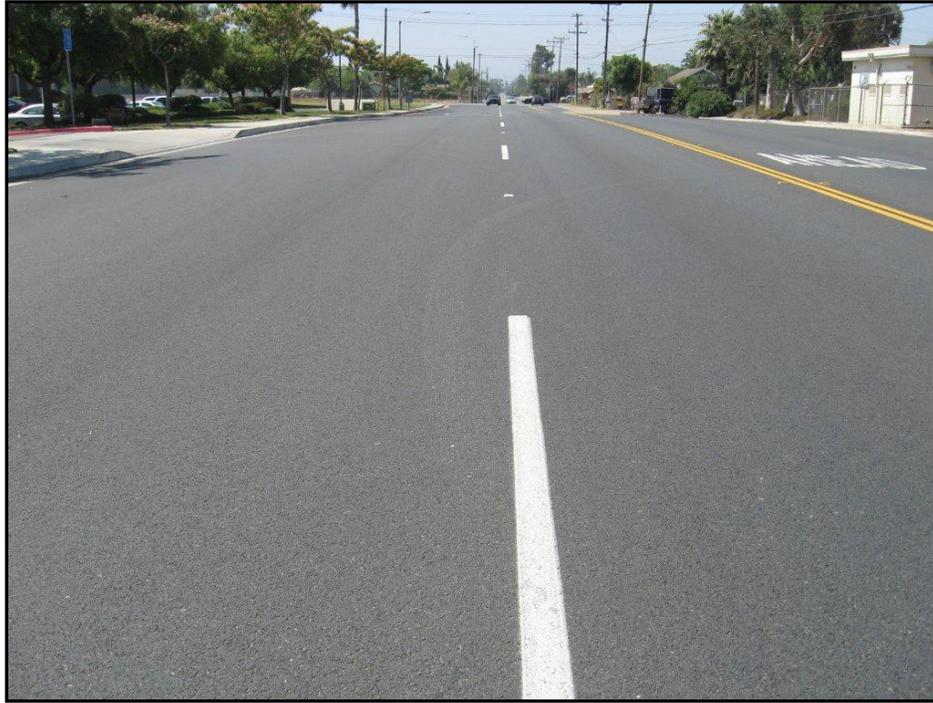
Figure 2A. PCI=98 (Excellent Condition)

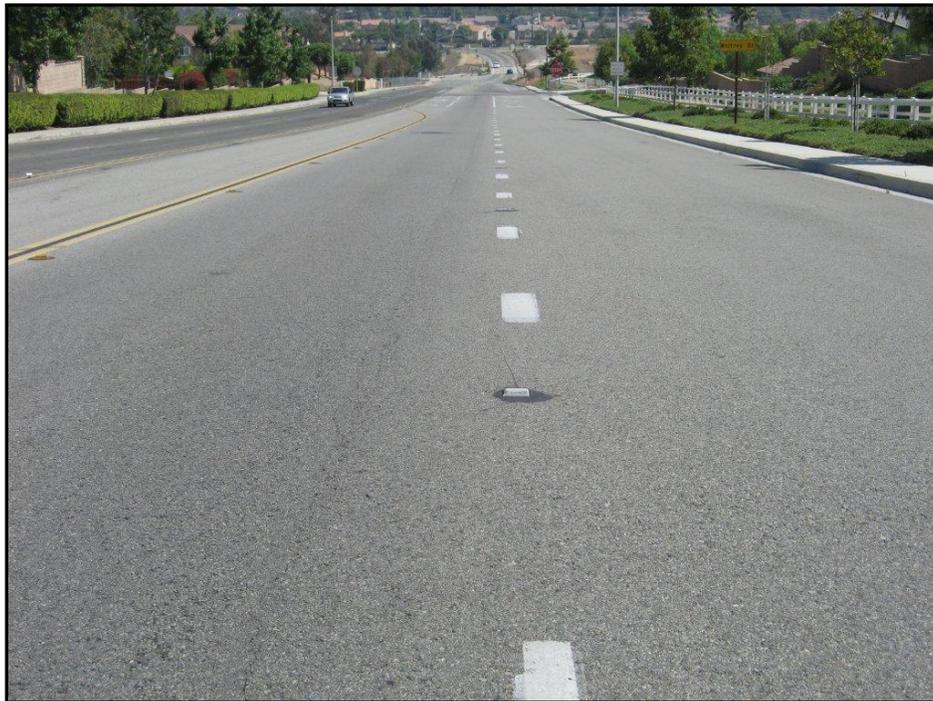
Figure 2B. PCI=85 (Very Good Condition)

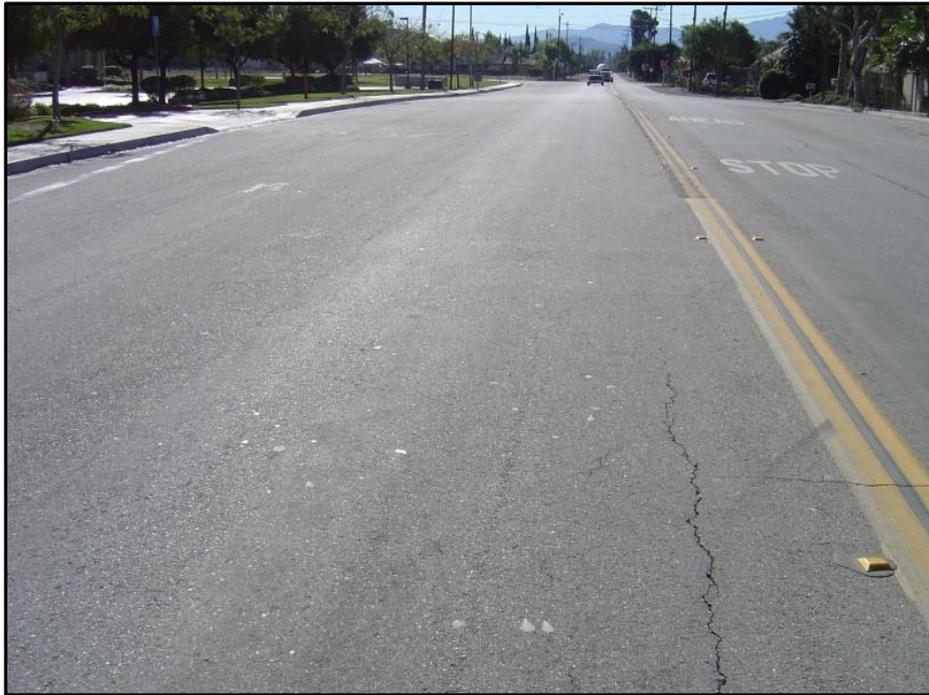
Figure 2C. PCI=78 (Good Condition)

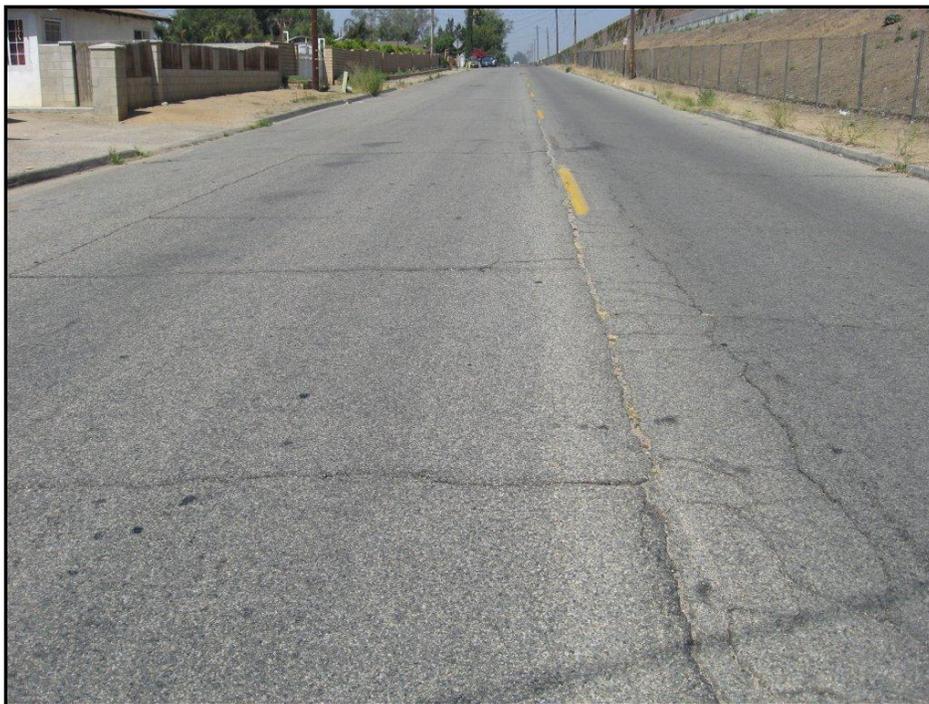
Figure 2D. PCI=56 (At Risk Condition)

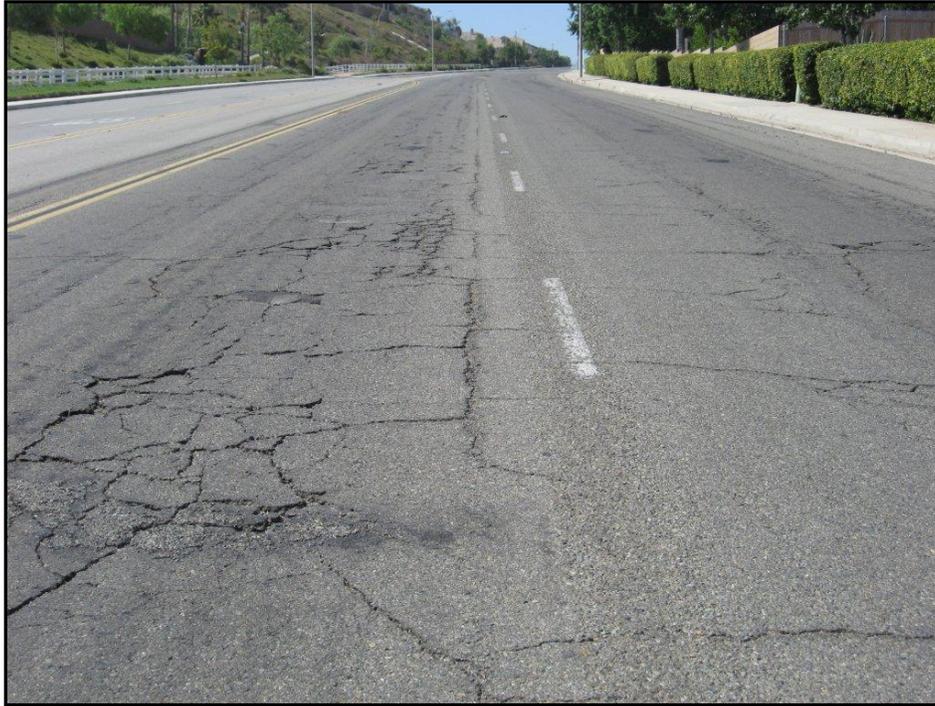
Figure 2E. PCI=30 (Poor Condition)

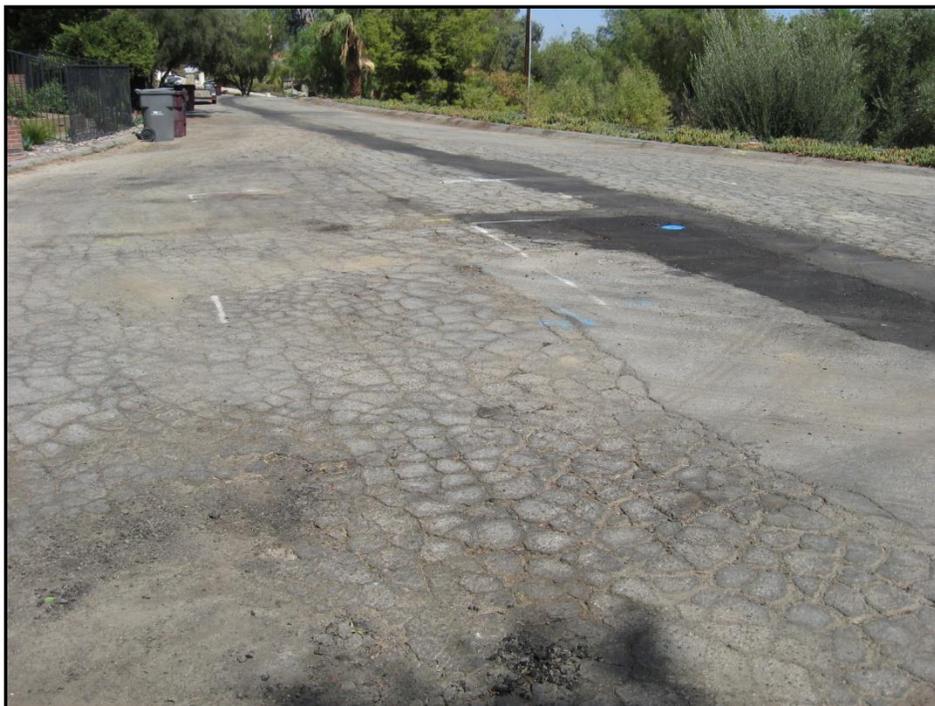
Figure 2F. PCI<10 (Very Poor Condition)

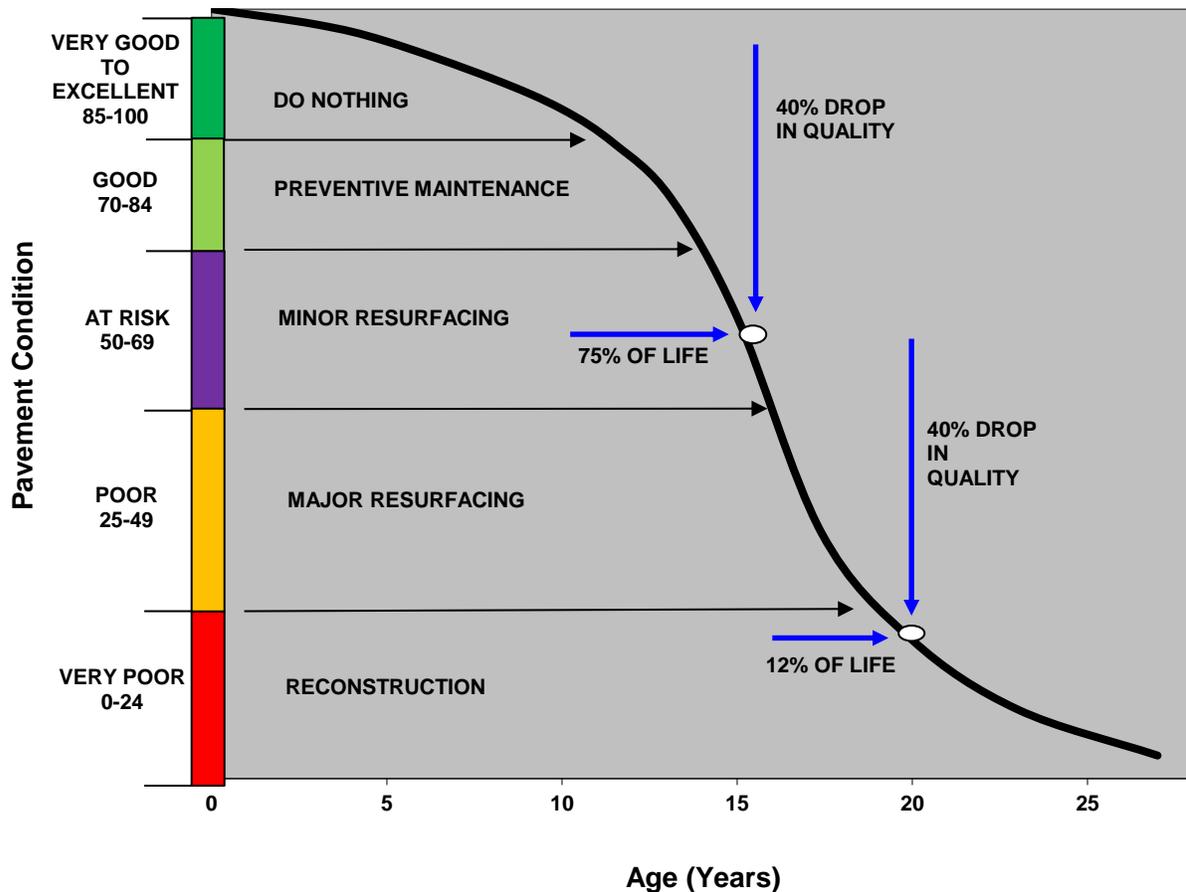
Figure 3. Pavement Deterioration Curve

A critical concept in overall pavement life is the timing of maintenance and rehabilitation (resurfacing or reconstruction) actions being undertaken before the pavement falls beyond the optimum rehabilitation point. Figure 3 demonstrates this concept. Notice that for the first 75 percent of pavement life, the pavement condition drops by about 40 percent. However, if left untreated, it only takes another 12 percent of pavement life for the pavement condition to drop another 40 percent. Additionally, in order to restore pavement condition to a predetermined or an acceptable minimum level (i.e., PCI of 70 or higher), it will cost 4 to 5 times as much if the pavement is allowed to deteriorate for 2 to 3 years beyond the optimum rehabilitation point (PCI of 50), as illustrated in Figure 3.

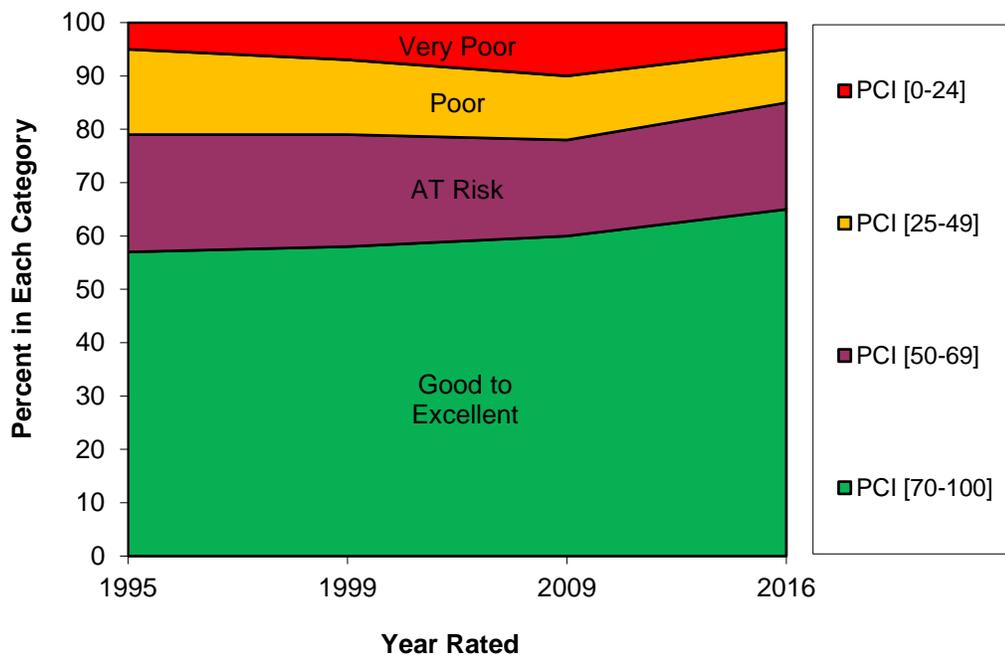
Figure 4. Pavement Condition Trendline (Countywide)

The percentage of mileage categorized by condition rating (good to excellent, at risk, poor, and very poor) over the last 20 years is summarized in Table 1. This table is also presented graphically showing the pavement condition trend in Figure 4 below.

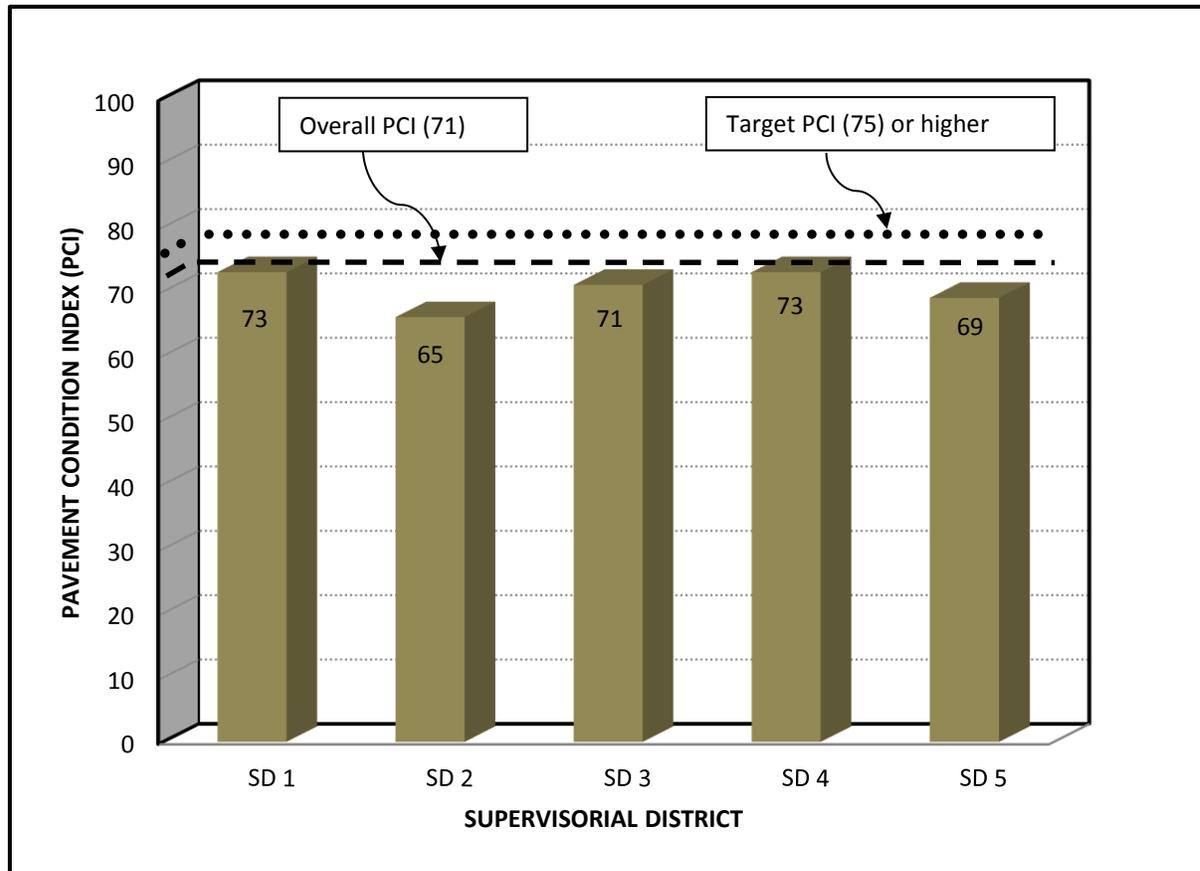
Figure 5. Pavement Condition Index by Supervisorial District

The Target PCI of 75 or higher, as shown in Figure 5, is based on a set goal that all pavements throughout the County road network system need to reach a condition where Best Management Practices (BMP) can occur. This means that generally the most cost-effective pavement preservation treatments are needed, such as, chip seal, slurry seal, cape seal, and thin overlay. Reaching and maintaining the target PCI offers other benefits (other than cost) such as reduced impact to the public in terms of:

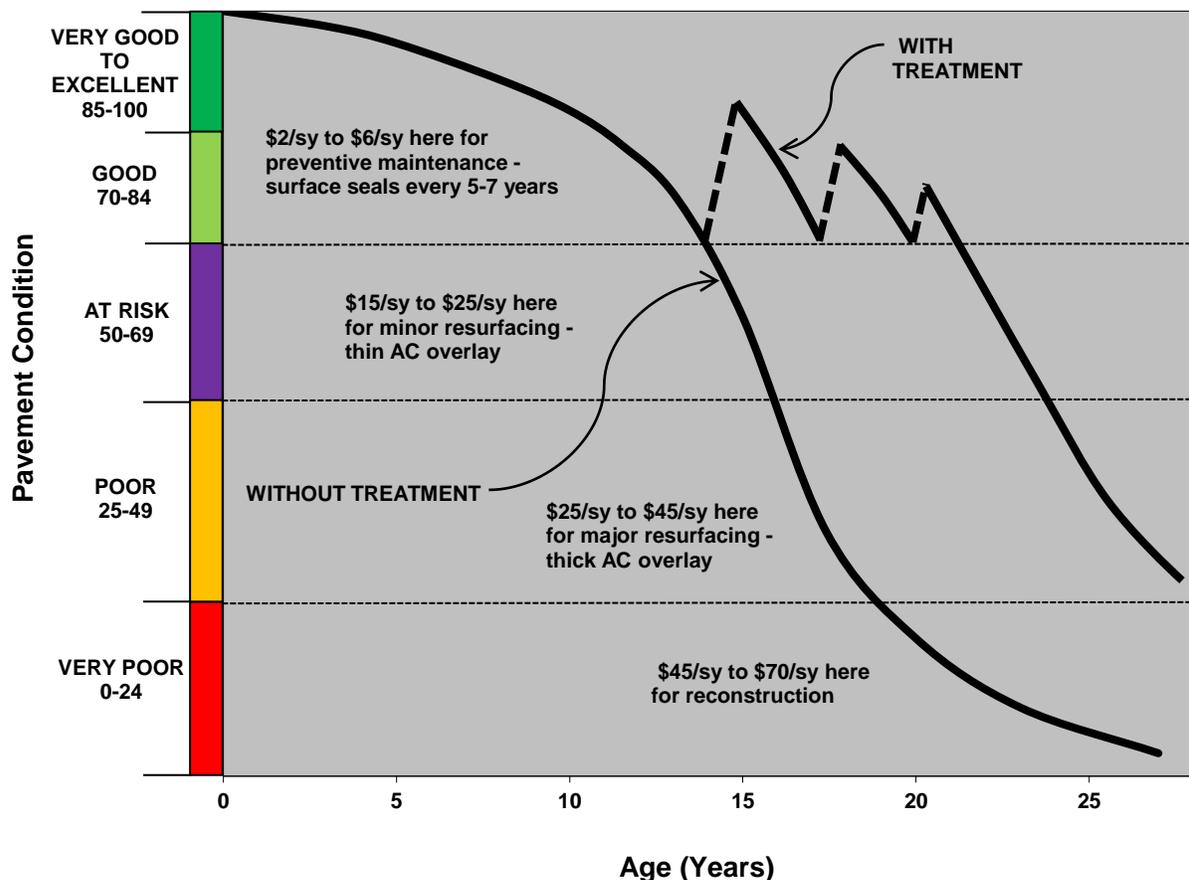
Figure 12. Pavement Deterioration Curve With and Without Treatment

An effective pavement preservation program will treat pavements while they are still in good condition and prior to the need for major reconstruction work. By applying a cost-effective treatment at the right time, the pavement is restored almost to its original condition. Figure 12 illustrates the concept of pavement preservation as it relates to enhancing pavement performance, extending pavement life, and ensuring taxpayer dollars are utilized wisely while providing improved safety and mobility to the public.

As depicted in Figure 12, the cumulative effect of systematic, successive preservation treatments is the postponement of costly resurfacing and reconstruction. During the life of a pavement, the cumulative discount value of the series of pavement preservation treatments is substantially less than the discounted value of the more extensive, higher cost of reconstruction and generally more economical than the cost of major resurfacing.

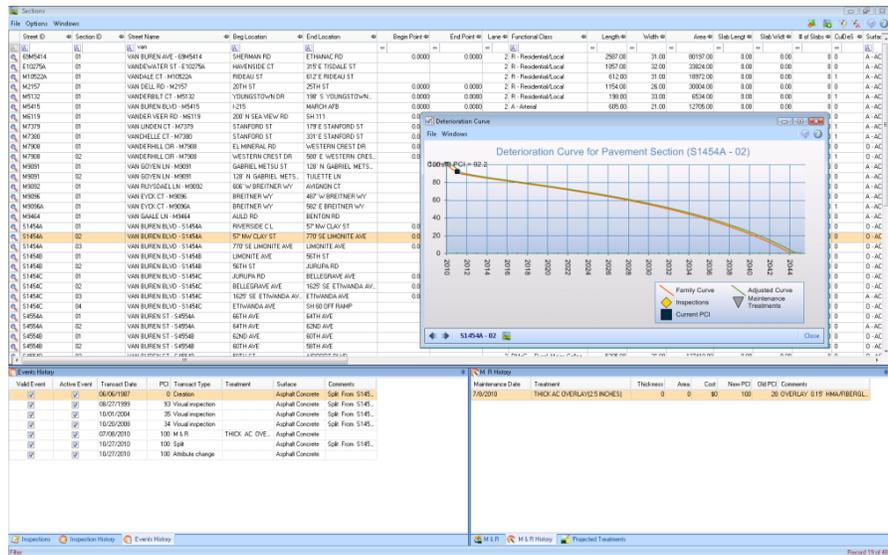
A Pavement Management Program (PMP) is a tool that assists the County in making cost-effective decisions related to the maintenance and rehabilitation of roadway pavements. It provides a decision-making process or system for rating pavement condition, establishing a consistent maintenance and repair schedule, and evaluating the effectiveness of maintenance treatment strategies. A PMP is also an optimizing tool that facilitates the prioritization of current and future needs to make the best use of available funds. The goal of a pavement management program is to strategize cost effective treatments to pavement sections that will deliver the best performance for the funds allocated. Simply put, a pavement management program saves public funds. An example of a PMP is shown in Figure 13.

Figure 13. Pavement Management Program - StreetSaver

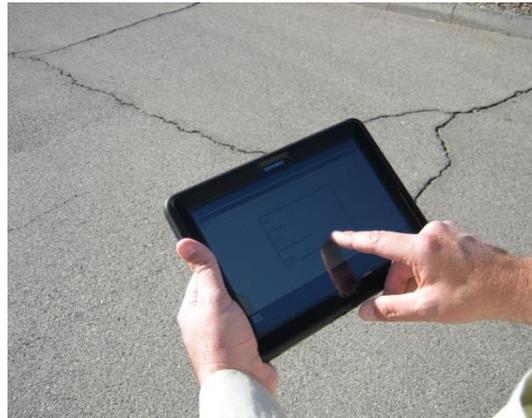
Inspection of pavement conditions is performed every year on one-fourth of the County's pavement network, which places all roads on a four-year inspection cycle. A field inspection or visual inspection survey is conducted by pavement raters (two-man crew) who walk each individual road segment evaluating the pavement for signs of distresses. In early 2012, the County switched its data collection approach from paper inspection sheets to a hand-held computer device, as depicted in Figure 14. Not only does a hand-held device accelerate the collection of pavement distress data, but it also reduces paper usage - an environmentally friendly methodology.

Figure 14. Tablet device use in road inspection.

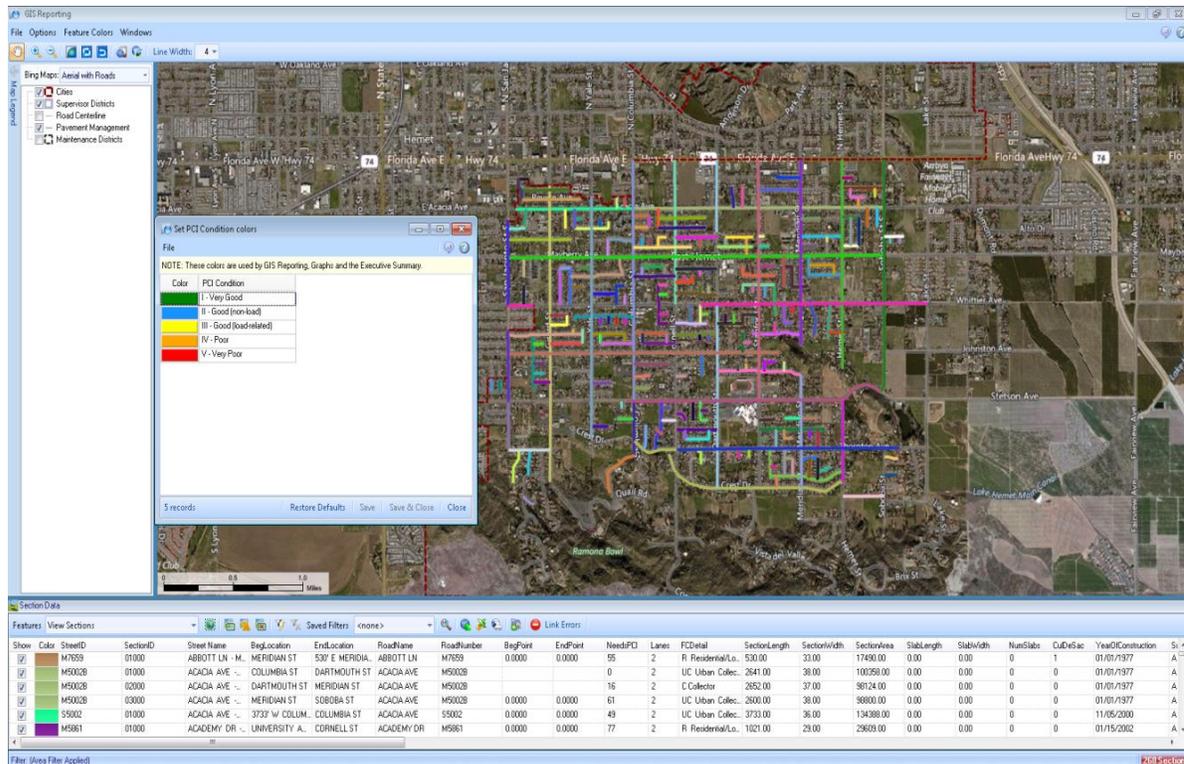
Figure 15. PMP result on GIS map.

The integration of the PMP with Geographic Information Systems (GIS) has provided the County a snapshot of the roadway network to better organize the data collected and facilitates in the decision-making in selecting roads to be included for treatment/repair in the upcoming fiscal year. An example of the PMP/GIS integration is shown in Figure 15.

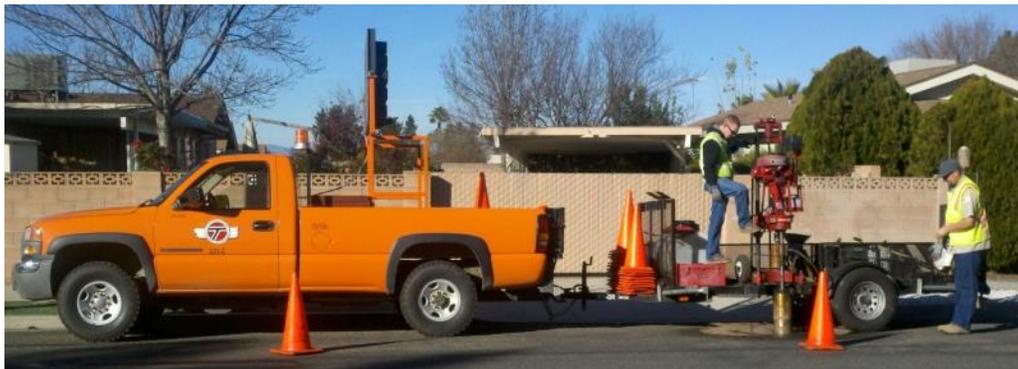
The County invests millions of dollars each year in pavement maintenance activities. Records of performance of the pavement maintenance treatments placed during these activities are crucial in order to determine which treatment alternative is the best option to use. With advancements in data collection practices and equipment, the County invested in a Ground Penetrating Radar (GPR) and a Falling Weight Deflectometer (FWD) in addition to its already established data collection methodology of using coring and visual inspection survey. Figure 16 and Figure 17 depict the road data collection equipment.

Figure 16. County's Coring Rig

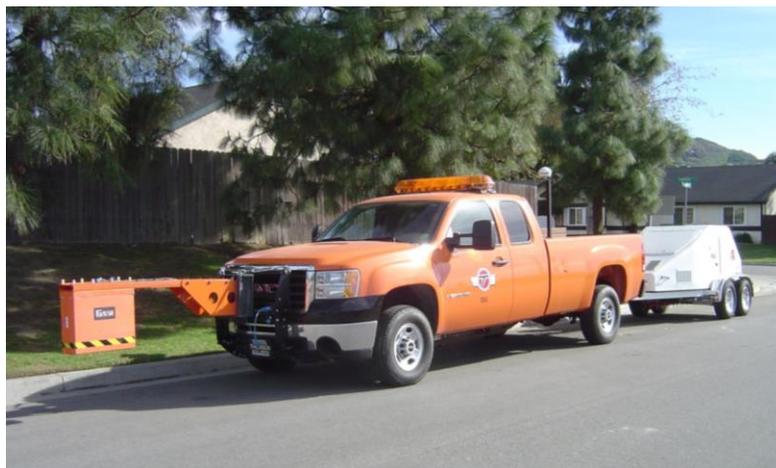
The GPR is used to measure pavement layer thickness and detect groundwater or voids beneath the pavement. The FWD characterizes pavement structural condition. Data collected from this state of the art equipment provide new information that can be used to improve pavement management recommendations as well as support the County's pavement rehabilitation and design activities.

Figure 17. FWD and GPR Data Collection Equipment

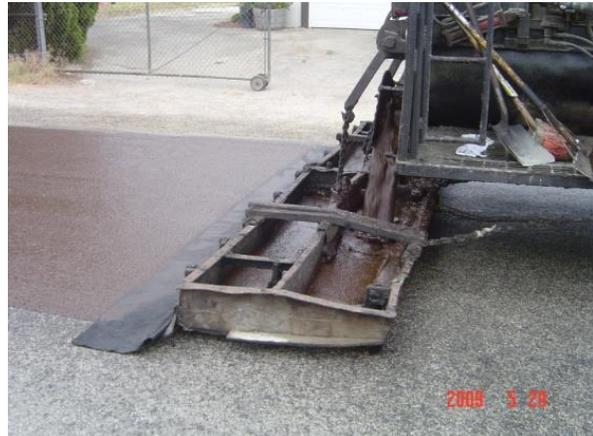
A slurry seal is a maintenance treatment applied to pavement to improve the functional characteristics of the pavement surface. It is a mixture of asphalt emulsion, aggregates and mineral fillers, which is mixed and placed in a continuous basis using a truck mixer. Prior to application, any surface distresses, such as cracks, are filled and sealed. After thoroughly mixing the emulsion, aggregates and mineral fillers in the slurry truck's built-in pug mill, the slurry mixture is poured into a spreader box. As the truck moves forward, the slurry is extruded from the backside of the spreader box, see Figure 19. The box is capable of spreading the slurry over the width of a traffic lane in a single pass resulting in a uniform application. The slurry cures as the water evaporates and turns the freshly placed brown slurry into black slurry. Traffic can be returned once the slurry has cured, which is usually four to six hours.

Figure 19. Spreading of slurry.

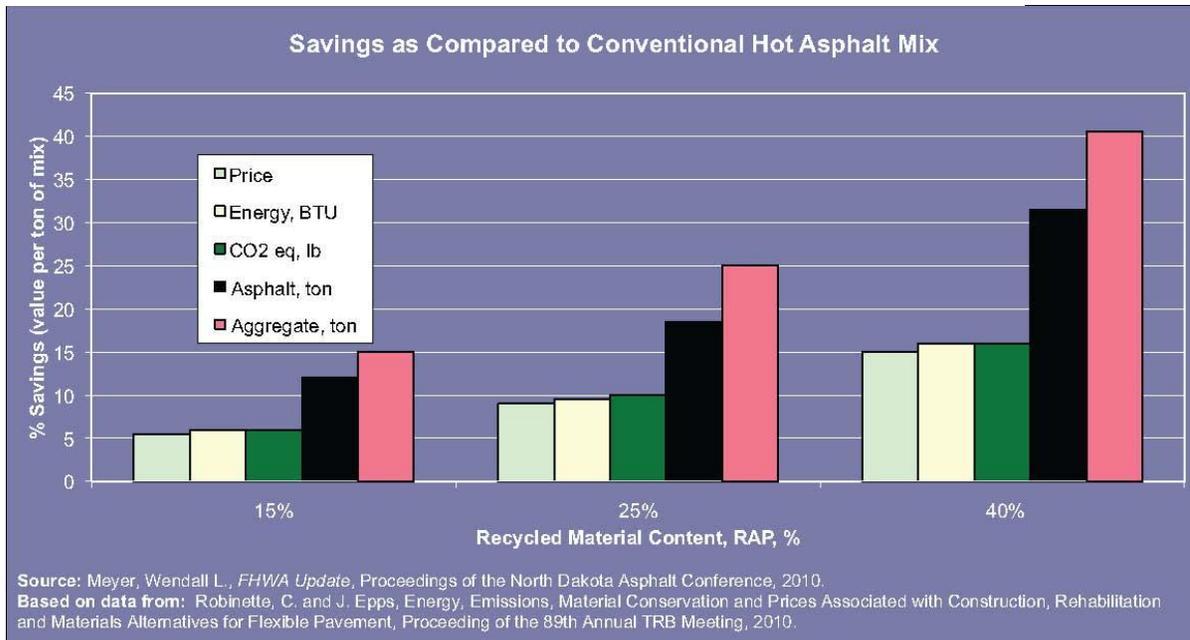
Figure 20. Benefits and Cost Savings of using RAP.

From the chart illustrated in Figure 20, some environmental benefits and cost savings of using at least 15 percent RAP in conventional HMA will yield a reduction in asphalt by about 12%, a decrease of virgin aggregate by about 15%, and a reduction of greenhouse gas emissions at a rate of 5 pounds per ton of RAP used in the hot mix asphalt.

Price corresponds to materials, construction, rehabilitation, and maintenance costs based on Life Cycle Cost Analysis (LCCA) with environmental impact assessment. Energy (BTU) represents the requirements for construction materials processing and construction material production. CO2 eq (lb) is a measure of greenhouse emissions and it includes the production of raw materials, transportation, production and laydown of materials. Asphalt and Aggregate in tons are considered the natural resources. [Sources: Transportation Research Board and Federal Highway Administration (FHWA)].
