COUNTY OF RIVERSIDE TRANSPORTATION DEPARTMENT

PAVEMENT MANAGEMENT REPORT 2020/21

**Riverside County Transportation Dept
2020/21 Pavement Management Report**

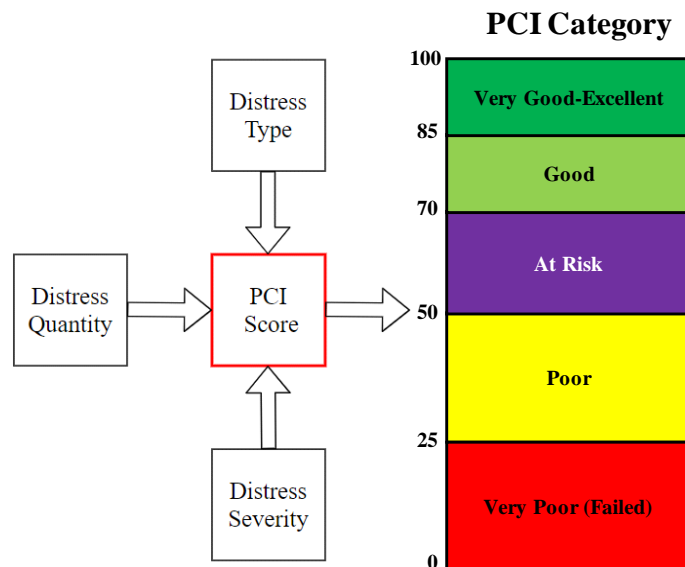
Figure ES.1 Pavement Condition Index Process and Categories

The Pavement Condition Index (PCI) method was used in assessing the condition of the County’s pave roads. The PCI method is an objective and repetitive method for assessing pavement condition and is widely used in industry. Pavement conditions were categorized based on PCI values using the criteria shown in Figure ES.1.

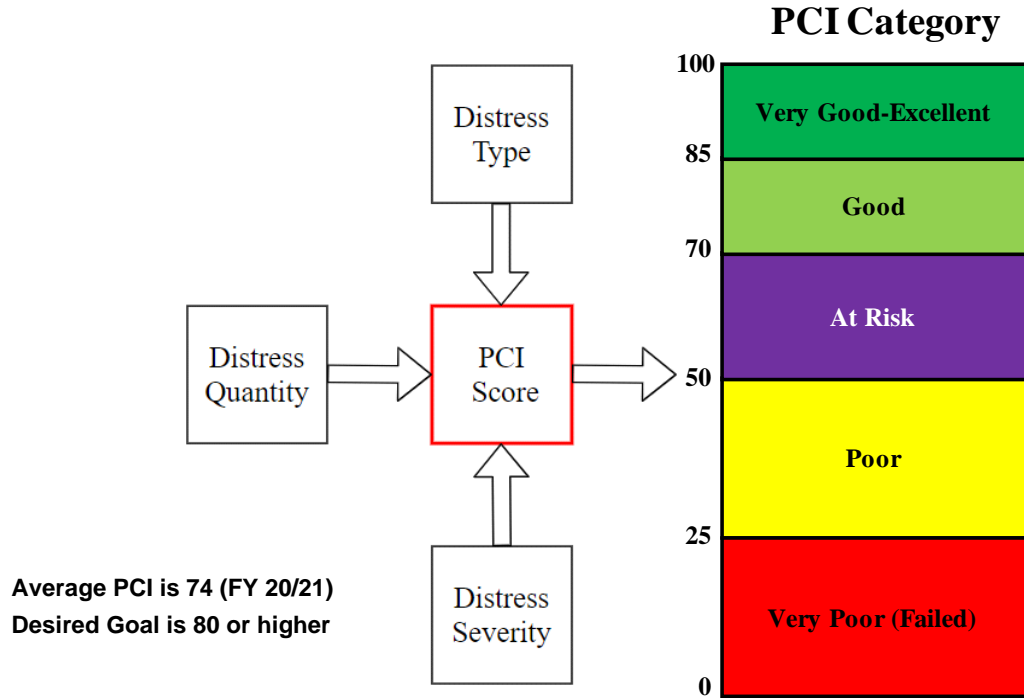
Figure 1. Relationship Between PCI and Pavement Condition

The MTC StreetSaver software combines the pavement condition assessment data from the visual inspection of the pavement frames to calculate the PCI. The PCI is based on the type, quantity, and severity of distresses from each segment of pavement. The PCI is a numerical index from 0 and 100. If properly designed and constructed, new pavements begin their service life with a PCI of 100. Due to the effects of loading and aging, the pavement deteriorates over time. For each combination of distress type, severity level, and quantity observed, points are deducted from 100, and the PCI decreases. Pavement management software, including StreetSaver, calculate the PCI scores for each pavement section based on a combination of distress types, severities, and quantities. Figure 1 shows the relationship between the PCI and pavement condition.

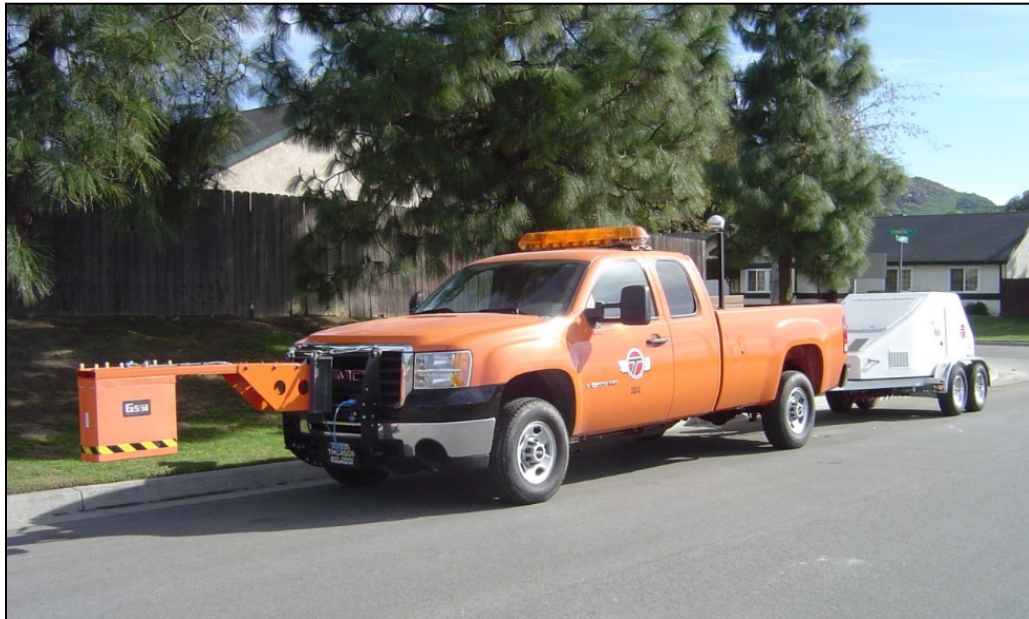
Figure 9. FWD and GPR Data Collection Equipment

The County invests millions of dollars each year in pavement maintenance activities. The Pavement Management Program (PMP) assists the County in determining the most cost-effective strategy for investing in pavement rehabilitation. In addition to the PMP tool, the County has invested in advanced structural data collection equipment including a Ground Penetrating Radar (GPR) and a Falling Weight Deflectometer (FWD). Figure 9 shows this advanced structural data collection equipment.

The GPR is used to measure pavement layer thickness and detect groundwater and voids beneath the pavement. The FWD is used to measure and evaluate the physical properties of the pavement structure. The use of the StreetSaver PMP which has been populated with data from the PCI inspection and with data collected from this state of the art equipment, provides the County pavement Engineer with adequate information to make informed decisions to best utilize available funding.

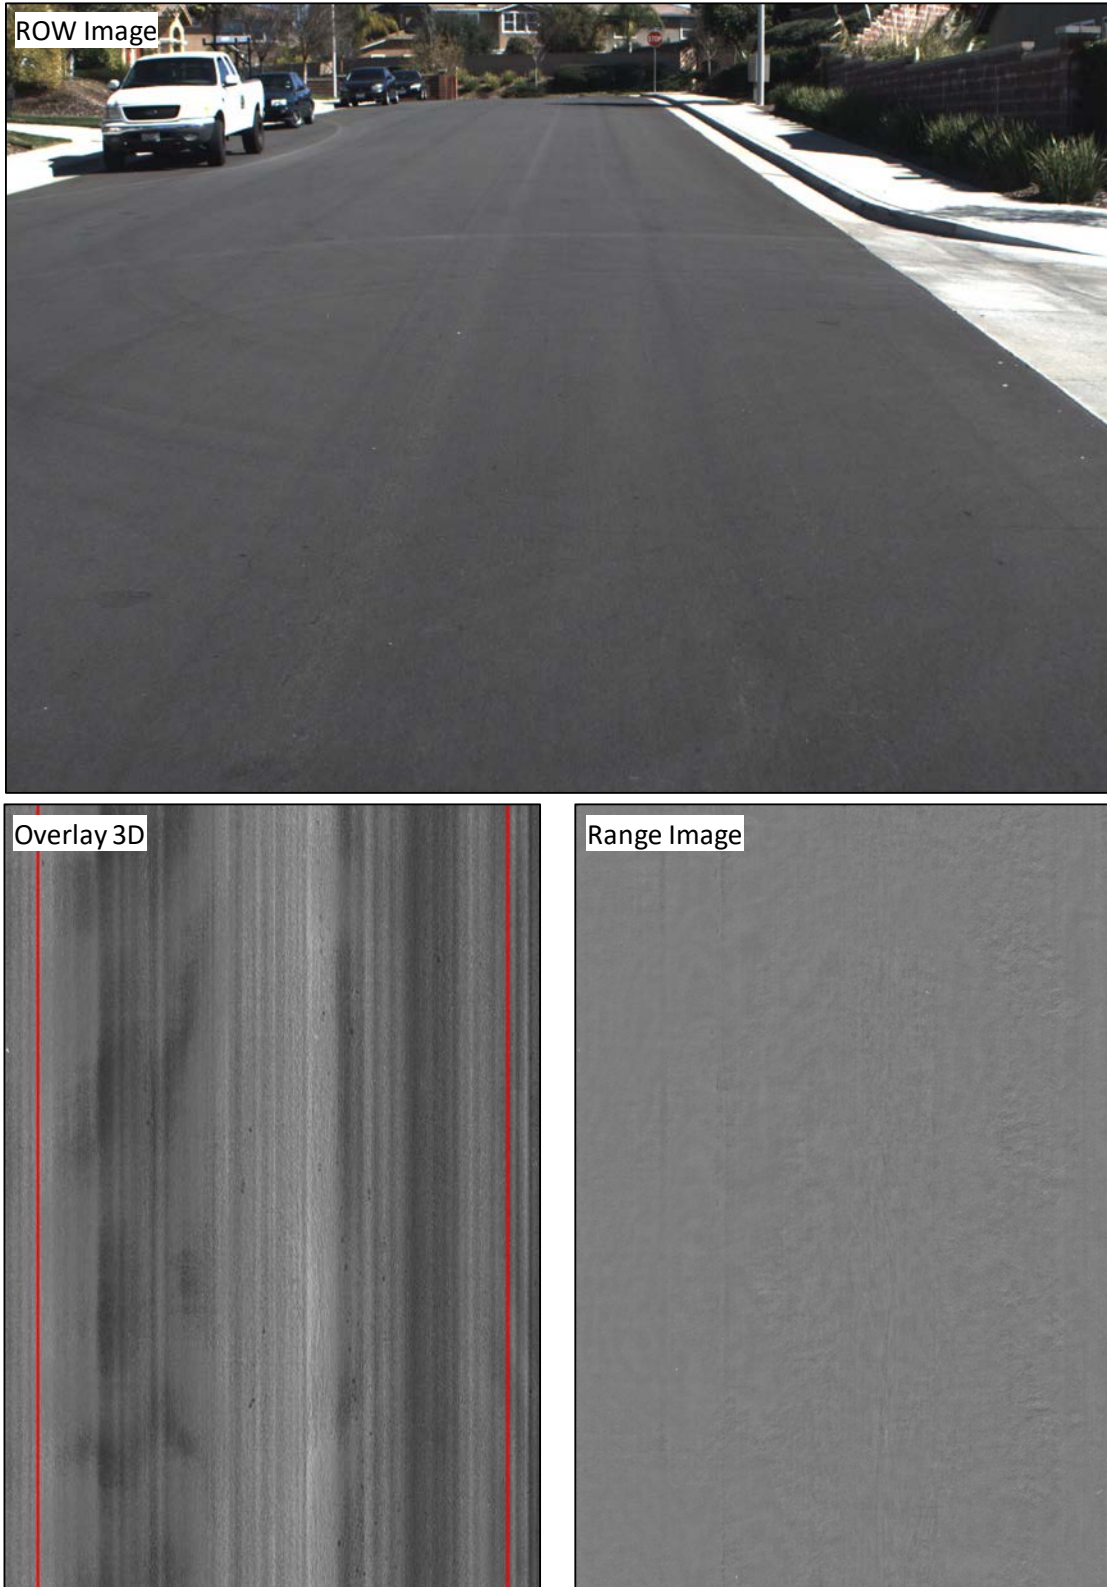
Figure 10A. PCI=99 (Excellent Condition)

Figures 10A to 10H show different pavement sections with decreasing PCI values. The images are the Right of Way (ROW) image, the 3D downward laser image with identified cracks highlighted, and the 3D range image that smooths surface texture to highlight crack details.

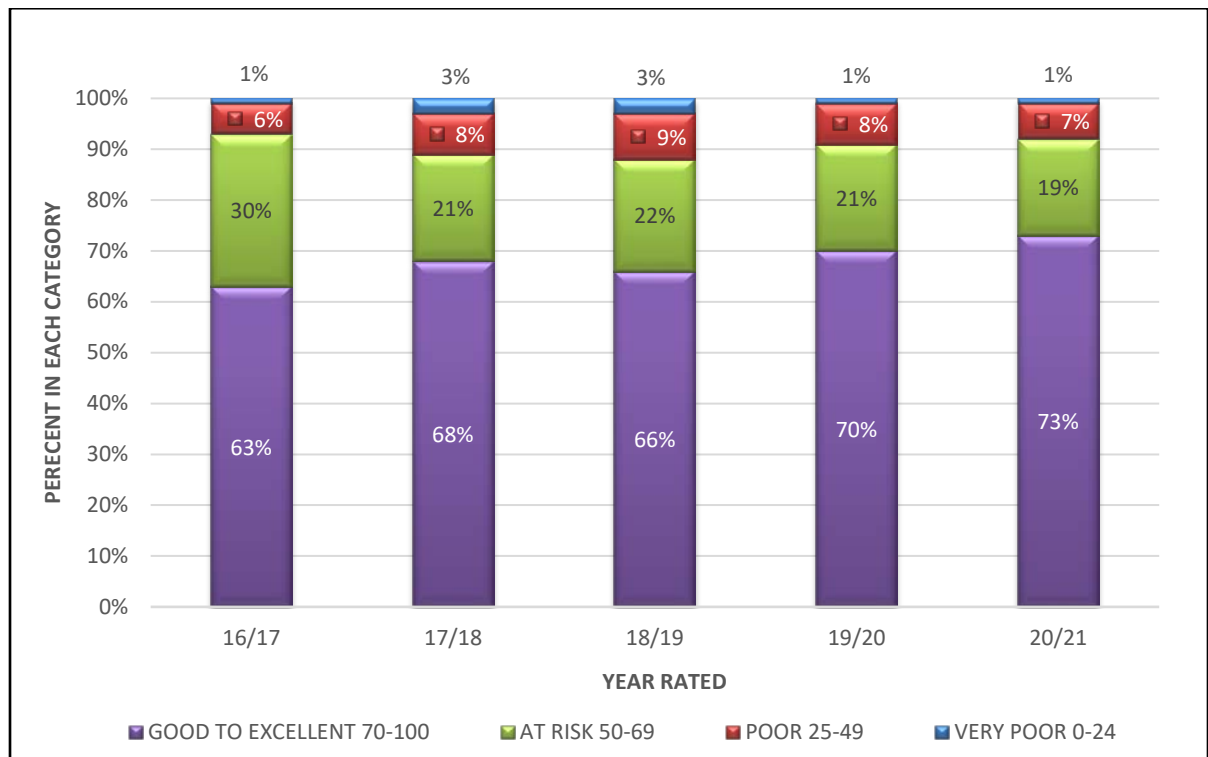
Figure 11. Pavement Condition Trend (Countywide)

The percentage of mileage categorized by condition rating (good to excellent, at risk, poor, and very poor) over the last 5 years is summarized in Table 2. This table is also presented graphically showing the pavement condition trend in Figure 11 below.

²) Distressed roads include roads from the AT RISK, POOR, and VERY POOR categories. Over the last 5 years, the percentage of distressed roads has been gradually declining from 37% to 27%.

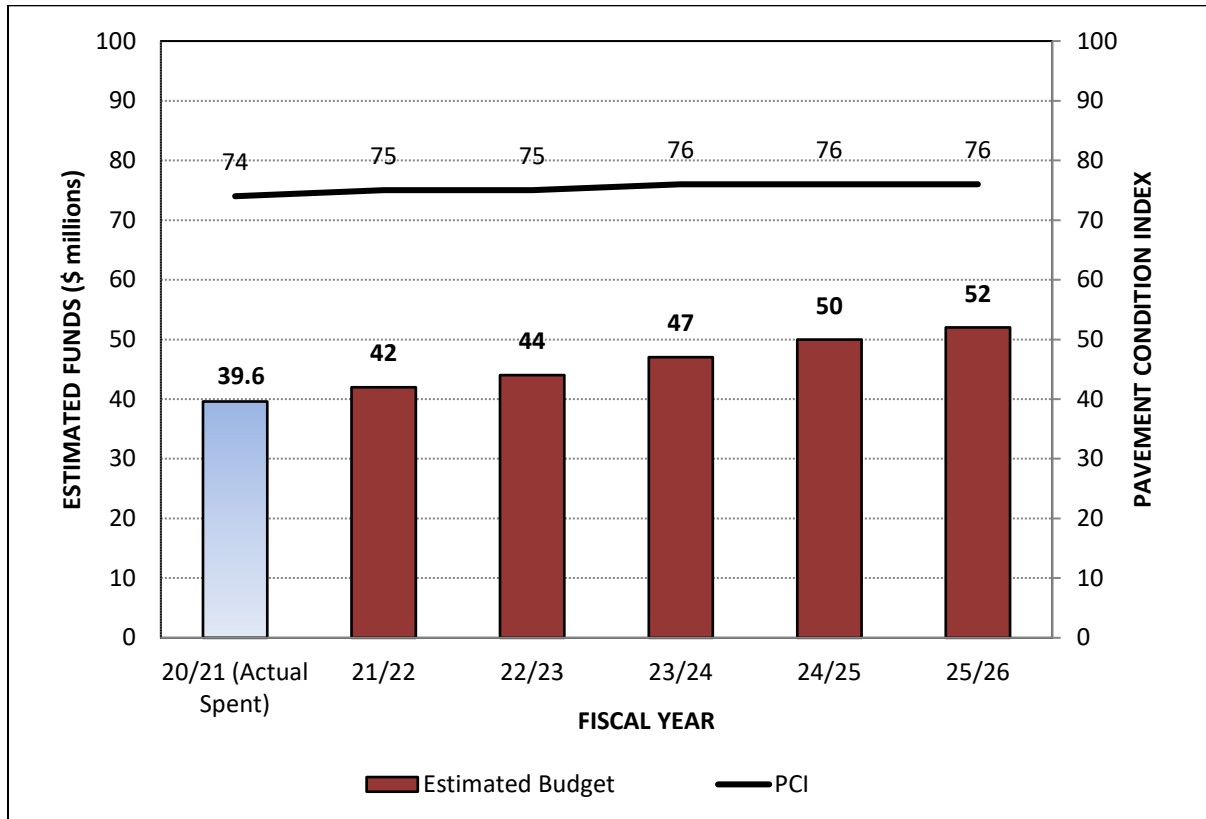
Figure 14. PCI based on Current Funding Projections

Note: The projected total budget is \$235 million over the next 5 years. Estimated budget is derived from revenue sources – SB 1, Measure A, and Gas Tax/HUTA.

With the passage of SB1 in April 2017 combined with other revenue sources, the overall condition of the road network is expected to improve in the long term. As can be seen in Figure 14, the PCI is projected to improve from 74 in FY 20/21 to 76 in FY 25/24. The PCI is projected to remain at 76 through 2026 with the projected funding. As was shown in Table 2, approximately 27 percent of the total maintained road miles throughout the County were identified to be in need of resurfacing or replacement in FY 2021. In order to reduce the percentage of distressed roads (roads identified as AT RISK, POOR, and VERY POOR) from 30 percent to 25 percent, it is estimated that it will cost at least \$235 million over a 5-year period. By attaining a PCI of 76, the distressed roads will decline to less than 25% of the road network. The desired goal is to have 20% or less distressed roads of the road network to maintain at a BMP level (PCI of 80 or greater).

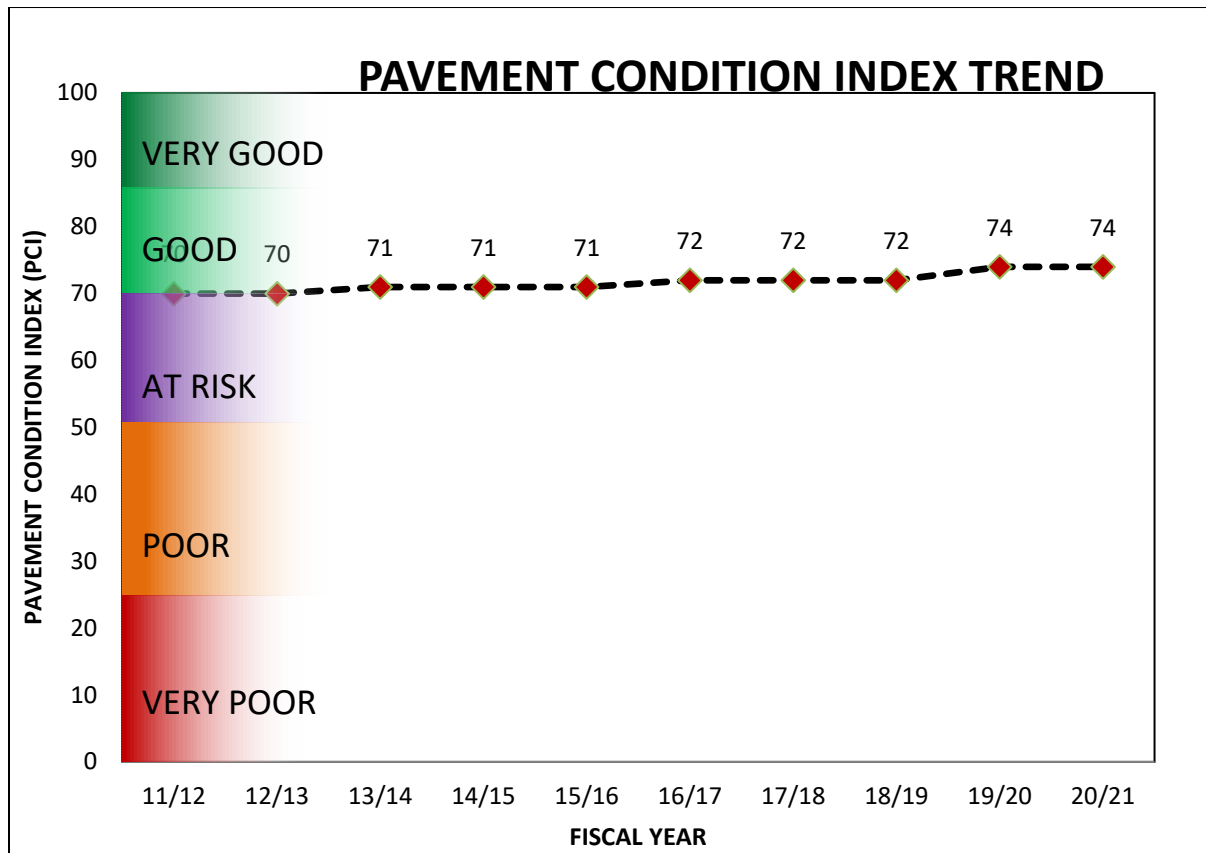
Figure 16. Pavement Condition Index Trend

Figure 16 below shows the PCI trend for the County for the last 10 years.

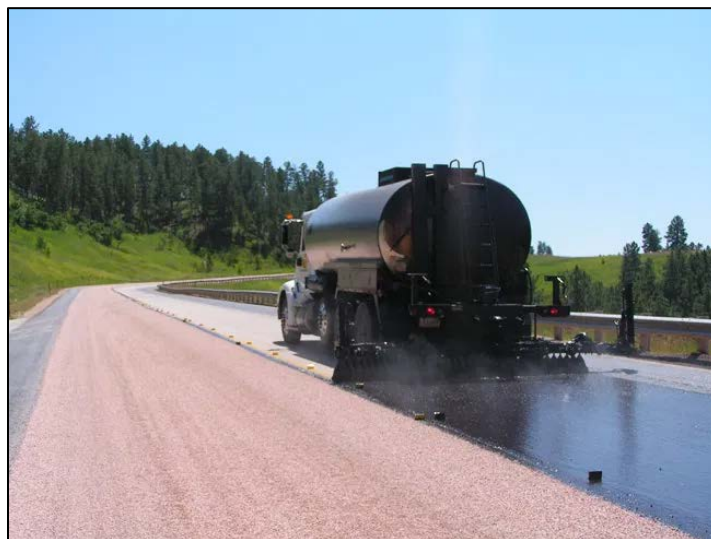
Figure 21. Chip Seal (slurry emulsion applied on right, chips applied on left)

A chip seal is a surface treatment applied to pavement with minimal surface distress to provide a new wearing surface, extend pavement life, and delay major rehabilitation or reconstruction. It is a process in which an asphalt emulsion is sprayed on the pavement then immediately covered by small crushed aggregate particles, also known as “chips.” Figure 21 illustrates the spreading of aggregate over the sprayed emulsion. When the asphalt emulsion is applied to the road surface in conjunction with a mechanized scrub broom (that forces the emulsion into the cracks), this process is called “scrub seal” (shown in Figure 22).

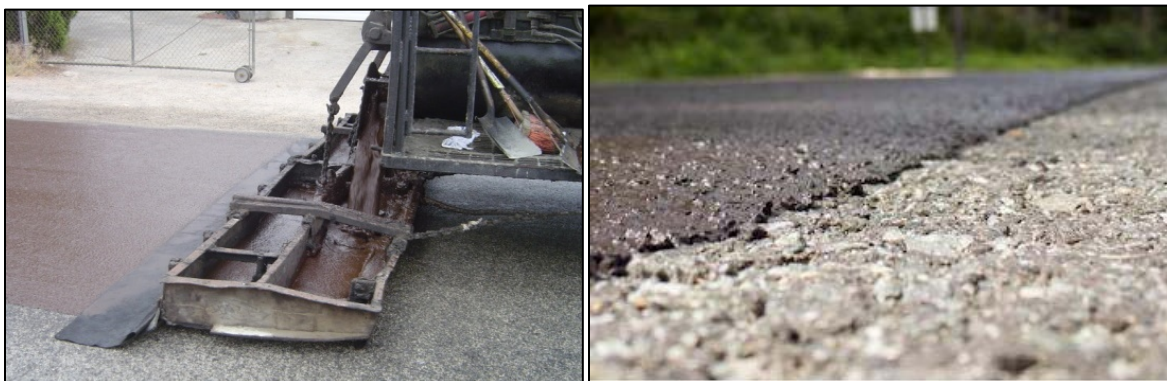
Figure 23. Spreading of Micro-surface Slurry

A slurry seal is a maintenance treatment applied to pavement to improve the functional characteristics of the pavement surface. It is a mixture of asphalt emulsion, aggregates, and mineral fillers. It is mixed and placed in a continuous basis using a truck mixer. A micro-surfacing is a maintenance treatment similar to slurry seal except it uses polymer modified and fast setting asphalt emulsion allowing thicker layers to be placed. The thick layer application allows the micro-surfacing slurry to fill in ruts commonly found on roads with light to moderate truck traffic. Prior to application, any surface distresses, such as cracks, are filled and sealed. After thoroughly mixing the emulsion, aggregates, and mineral fillers in the slurry truck's built-in pug mill, the slurry mixture is poured into a spreader box. As the truck moves forward, the slurry is extruded from the backside of the spreader box, see Figure 23. The box is capable of spreading the slurry over the width of a traffic lane in a single pass resulting in a uniform application. The slurry cures as the water evaporates and turns the freshly placed brown slurry into black slurry. Traffic can be returned once the slurry has cured, which is usually two to four hours.

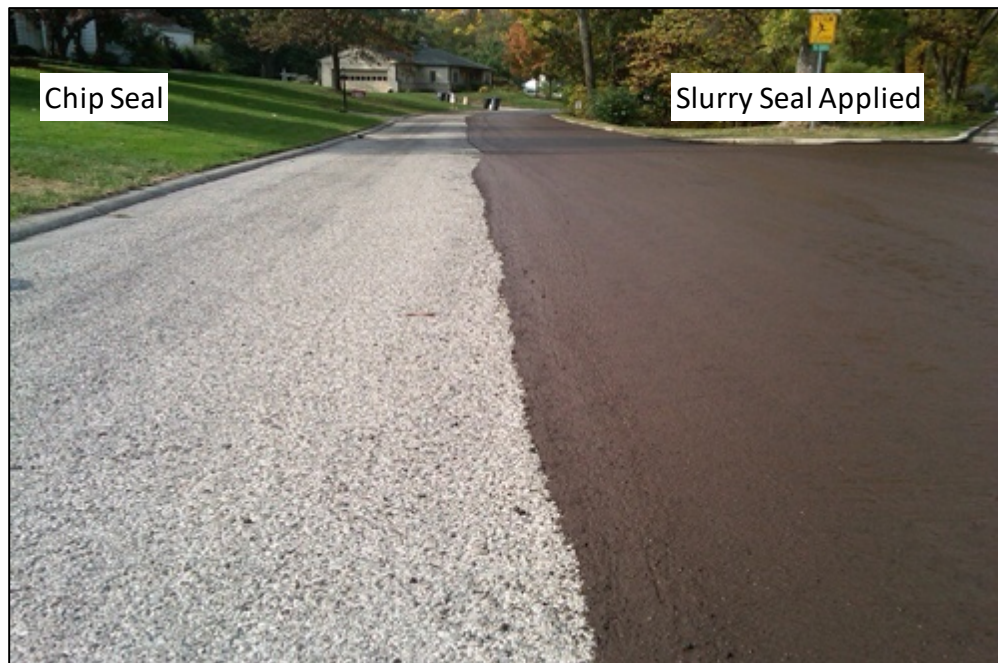
Figure 24. Cape Seal

Cape seal treatment consists of a bottom course of a chip seal covered with a wearing course of slurry seal to lock the aggregate chips in place (Figure 24). Preventing the aggregate from the chip seal application from being dislodged is particularly useful for roads with curb and gutter where loose chips can fill the gutter. In addition, chip seals are also not popular with the public because of the rough ride and the loose chips that are picked up by vehicles.

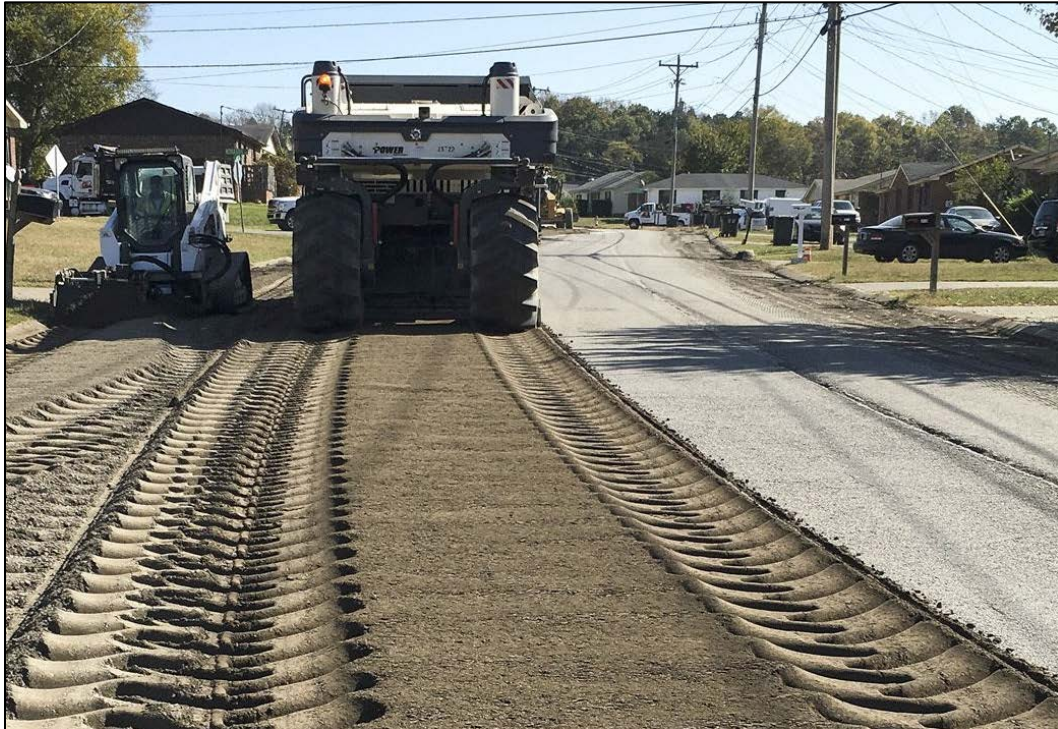
Figure 26. Full Depth Reclamation (FDR)

Full-Depth Reclamation (FDR) involves the pulverization of the asphalt layers of the pavement and a portion of the underlying materials in-place four to ten inches deep, removing any excess material, and then stabilizing the materials with cement, foam asphalt, or asphalt emulsion (Figure 26). The new material is shaped and compacted in preparation for a new wearing surface such as hot mix asphalt. The wearing surface is placed within one to three days of completing the FDR material.

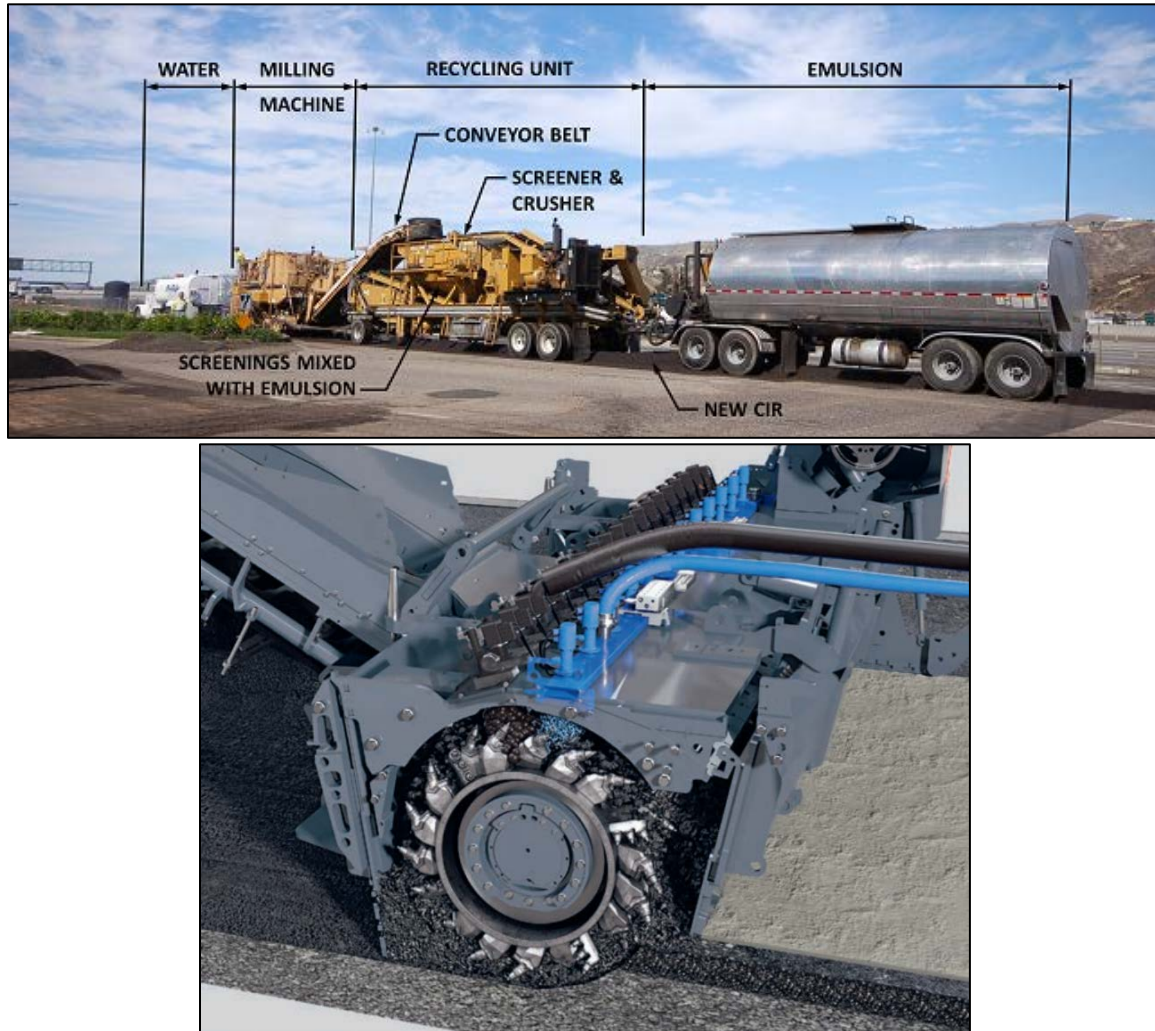
Figure 27. Cold In-Place Recycling (CIR)

Another method that involves the reuse of pavement material is Cold In-Place Recycling (CIR). Pavement is removed by cold planning or milling 3 to 4 inches of material, leaving a small amount of pavement to support the equipment during the construction process (Figure 27). The material is crushed, sized, and mixed with an asphalt emulsion and other additives. Then the material is immediately placed and compacted. Within two to five days of placing the CIR material, a layer of hot mix asphalt is placed. Typically, a 3-piece “train” is used consisting of a cold planning machine, a screening/crushing/mixing unit, and conventional laydown and rolling equipment. This “train” occupies only one lane, thus maximizing traffic flow.

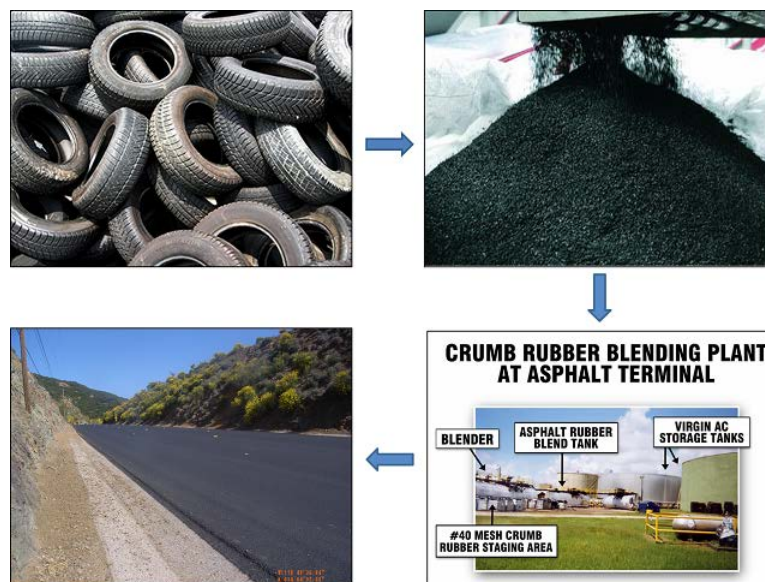
Figure 28. Rubberized Asphalt Concrete using Crumb Rubber

Rubberized asphalt concrete (RAC) is a road paving material made by blending and heating ground tire rubber with asphalt to produce a binder, which is then mixed with conventional aggregate materials (Figure 28). This mix is then placed and compacted into a road surface.

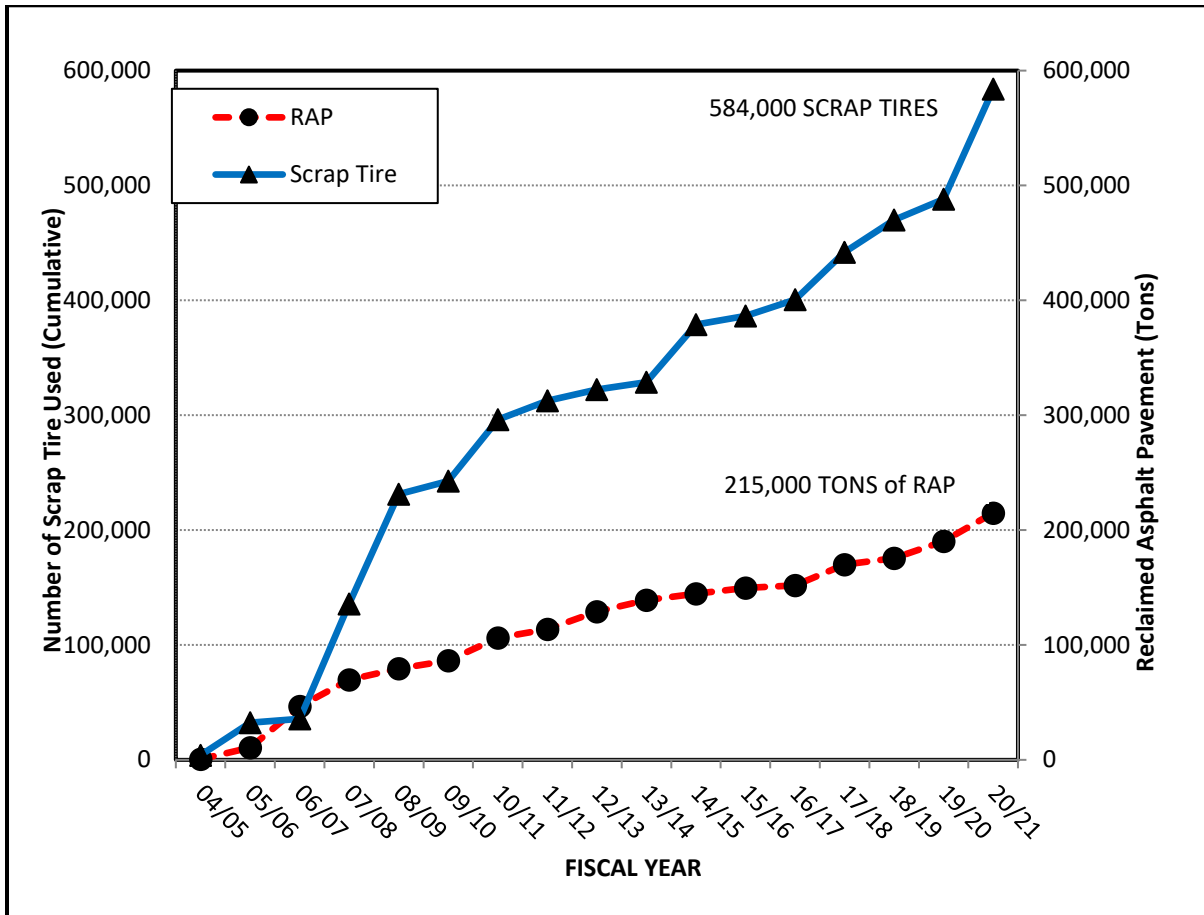
Figure 30. Benefits and Cost Savings of using RAP

- 215,000 tons of RAP used in HMA which translate to a reduction of 1,075,000 pounds of carbon emissions.
- 584,000 scrap tires diverted from the landfill by substituting RAC in HMA.
