PAVEMENT MANAGEMENT REPORT

2013

**COUNTY OF RIVERSIDE
TRANSPORTATION DEPARTMENT**

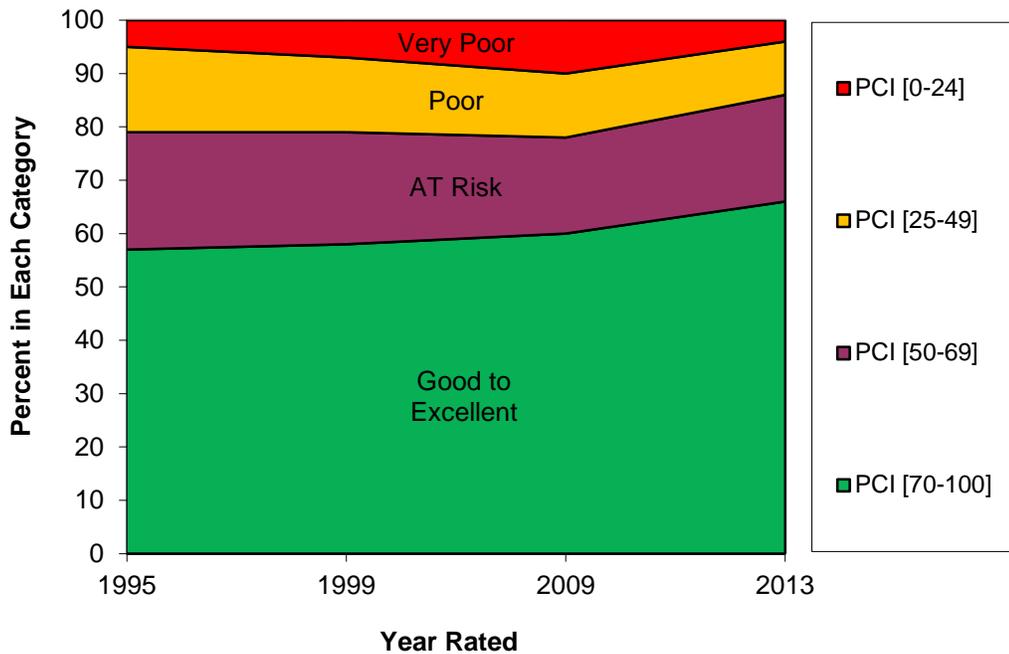
Figure 1. Pavement Condition Trendline (Countywide)

The percentage of mileage categorized by condition rating (good to excellent, at risk, poor, and very poor) over the last 18 years is summarized in Table 3. This table is also presented graphically showing the pavement condition trend in Figure 1 below.

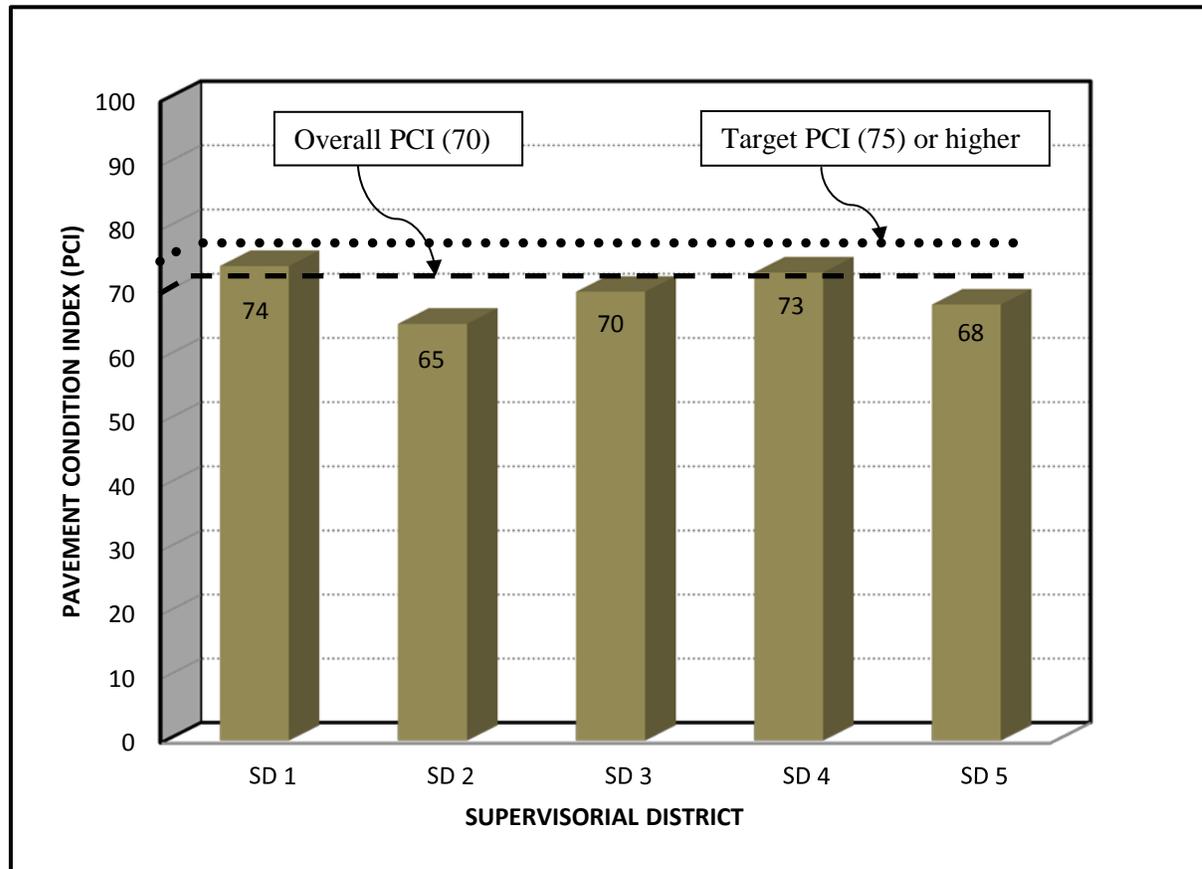
Figure 2. Pavement Condition Index by Supervisorial District

The Target PCI of 75, as shown in Figure 2, is based on a set goal that all pavements throughout the County road network system need to reach a condition where Best Management Practices (BMP) can occur. This means that only the most cost-effective pavement preservation treatments are needed, such as, chip seal, slurry seal, and cape seal. Reaching and maintaining the target PCI offers other benefits (other than cost) such as reduced impact to the public in terms of:

As noted on the chart in Figure 2, the overall PCI of 70 is considered “Good” by definition of PCI shown in Figure 7 (page 1), “Relationship between PCI and Condition,” of this report. From the generalized pavement deterioration curve shown in Figure 9 (page 5), “Pavement Deterioration Curve,” of this report, a PCI below 70 signifies a pavement at risk. The roadway network’s life and deterioration accelerates rather rapidly at a PCI between 50 and 69 and if repairs are delayed by just a few years, preventative maintenance could increase the cost of the treatment significantly, as much as ten times.

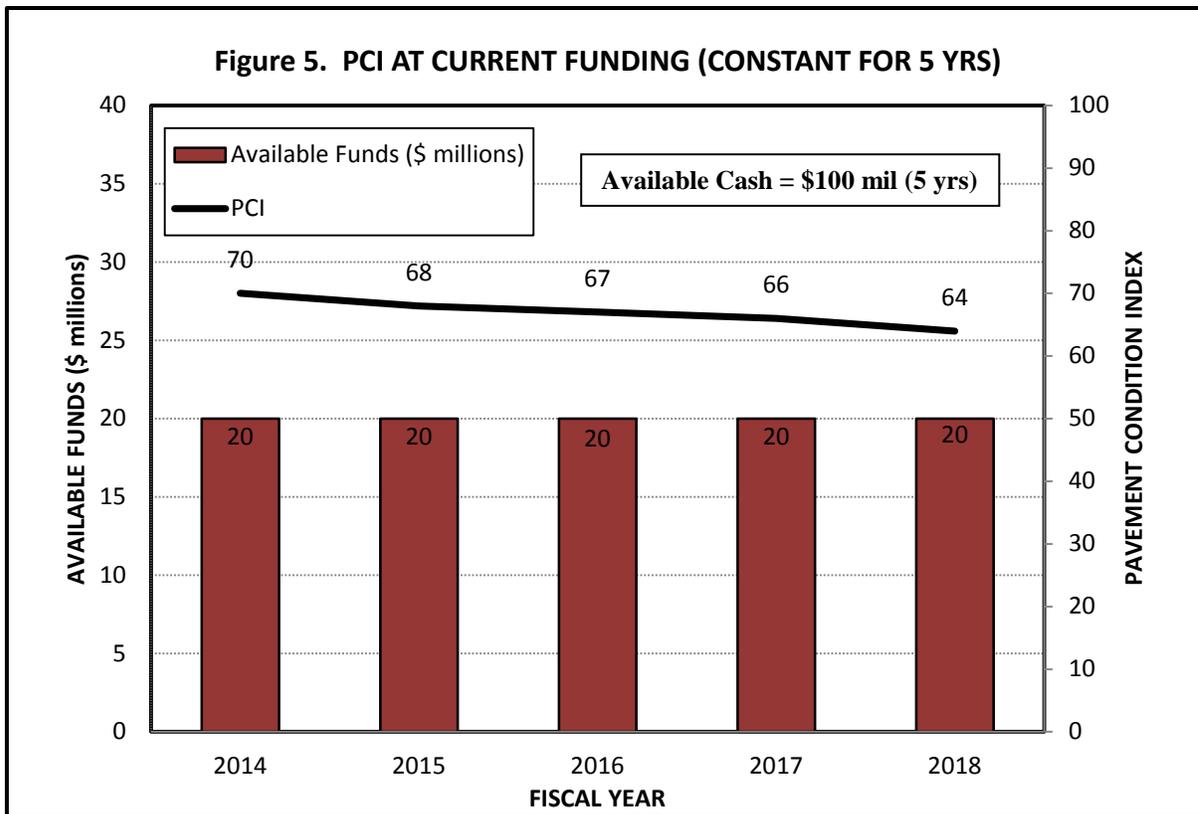
As illustrated by the funding scenario in Figure 5, maintaining the current funding of \$20 million annually for the next 5 years will have an impact on the PCI of the road network. Initially for the first year, the PCI will be 70 starting in 2014 then gradually declining to 64 over a 5-year period.

Given the two funding scenarios illustrated in Figure 5 and Figure 6 for the needs and available cash, the funding shortfall can be calculated. For each scenario, the total cost or available cash is simply the sum of each cost or available cash per year for 5 years. As depicted in Table 4, the shortfall is \$183 million. Clearly, the available funding is inadequate in meeting the BMP goal within the period analyzed. Based on the results of this analysis, approximately \$183 million of additional funding is needed to bring the pavement condition of the county roads to an overall PCI of 75.

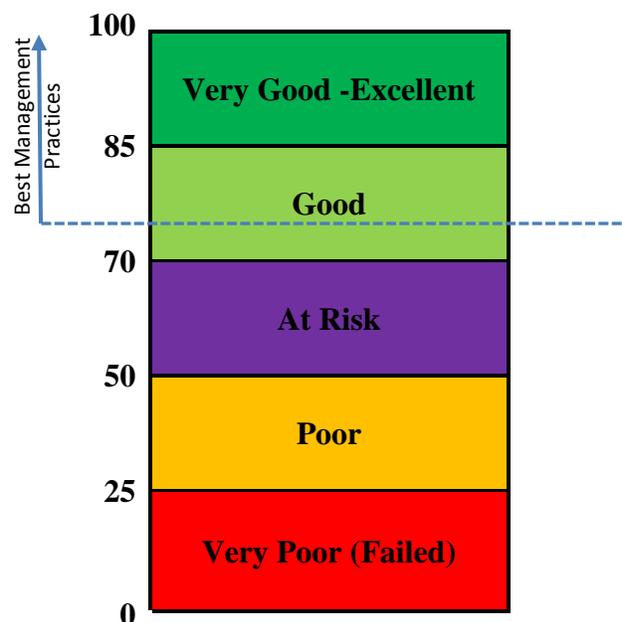
Figure 7. Relationship Between PCI and Condition

In the MTC StreetSaver software, the pavement condition assessment is based on collecting data to determine the type, amount, and severity of surface distress for each segment of pavement being managed. The distress data is used to calculate a Pavement Condition Index (PCI), which is based on a visual survey of the pavement and a numerical index between 0 and 100, with 0 being defined as failed roadway and 100 representing an excellent pavement (newly paved). Figure 7 shows the relationship between the PCI and pavement condition. Photos showing examples of pavement in excellent through very poor condition are shown in Figure 8A through 8F.

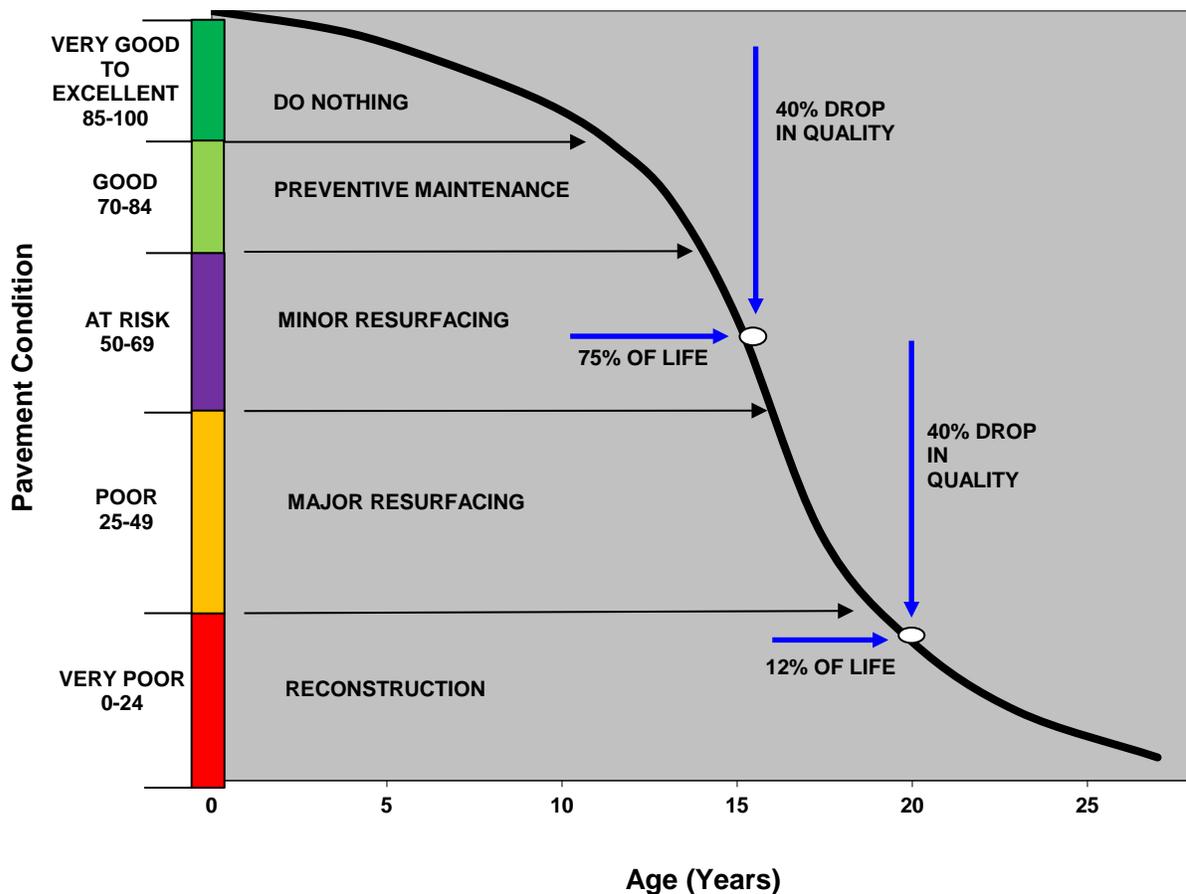
Figure 9. Pavement Deterioration Curve

A critical concept in overall pavement life is the timing of maintenance and rehabilitation (resurfacing or reconstruction) actions being undertaken before the pavement falls beyond the optimum rehabilitation point. Figure 9 demonstrates this concept. Notice that for the first 75 percent of pavement life, the pavement condition drops by about 40 percent. However, if left untreated, it only takes another 12 percent of pavement life for the pavement condition to drop another 40 percent. Additionally, in order to restore pavement condition to a predetermined or an acceptable minimum level (i.e., PCI of 70 or higher), it will cost 4 to 5 times as much if the pavement is allowed to deteriorate for 2 to 3 years beyond the optimum rehabilitation point (PCI of 50), as illustrated in Figure 9.

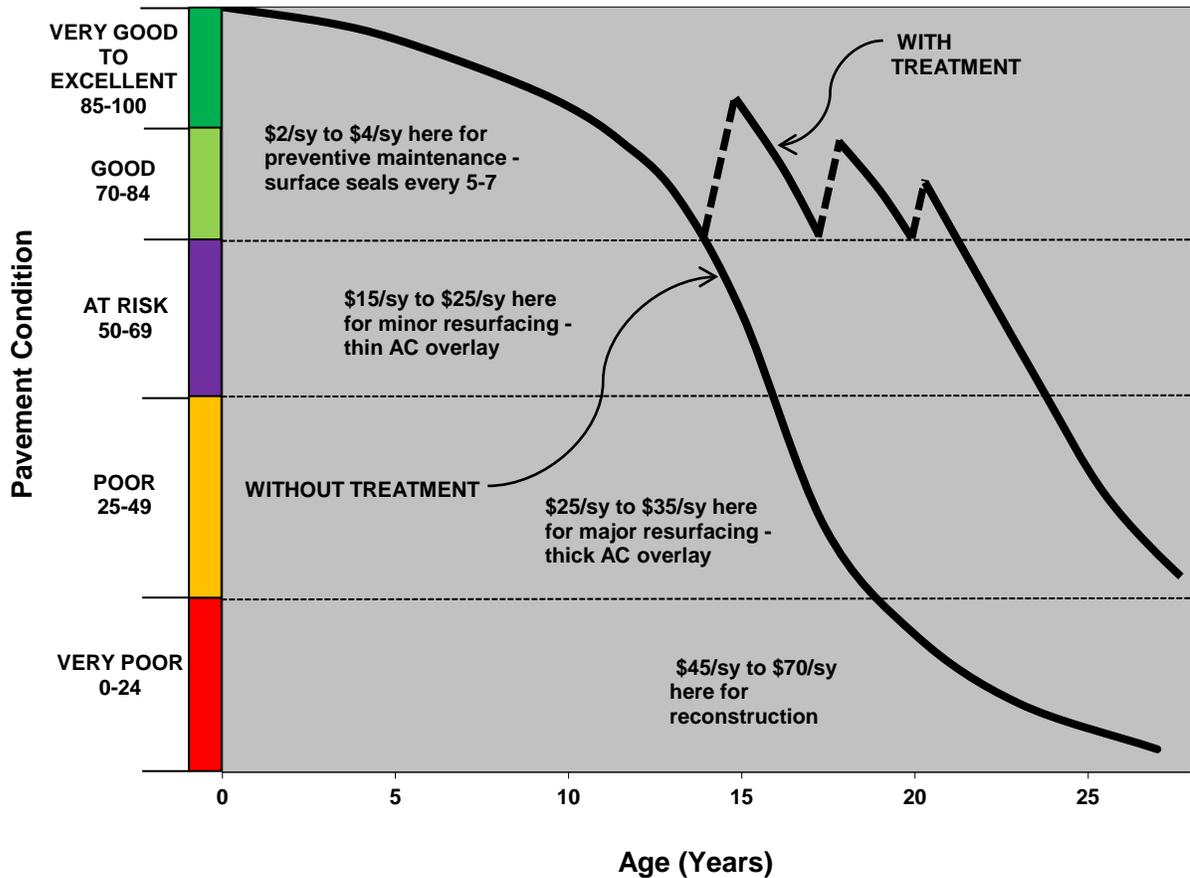
Figure 10. Pavement Deterioration Curve With and Without Treatment

An effective pavement preservation program will treat pavements while they are still in good condition and prior to the need for major reconstruction work. By applying a cost-effective treatment at the right time, the pavement is restored almost to its original condition. Figure 10 illustrates the concept of pavement preservation as it relates to enhancing pavement performance, extending pavement life, and ensuring taxpayer dollars are utilized wisely while providing improved safety and mobility to the public.

As depicted in Figure 4, the cumulative effect of systematic, successive preservation treatments is the postponement of costly resurfacing and reconstruction. During the life of a pavement, the cumulative discount value of the series of pavement preservation treatments is substantially less than the discounted value of the more extensive, higher cost of reconstruction and generally more economical than the cost of major resurfacing.

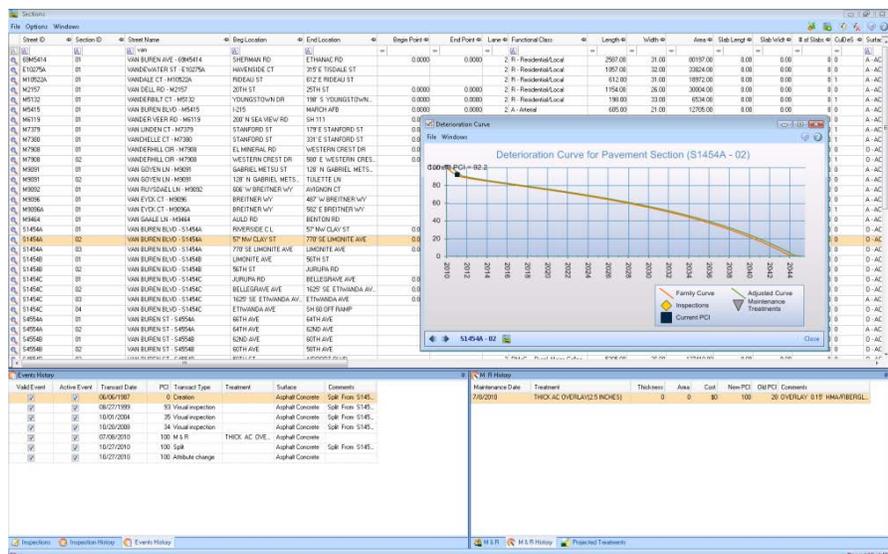
Figure 11. Pavement Management Program - StreetSaver

A Pavement Management Program (PMP) is a tool that assists the County in making cost-effective decisions related to the maintenance and rehabilitation of roadway pavements. It provides a decision-making process or system for rating pavement condition, establishing a consistent maintenance and repair schedule, and evaluating the effectiveness of maintenance treatment strategies. A PMP is also an optimizing tool that facilitates the prioritization of current and future needs to make the best use of available funds. The goal of a pavement management program is to strategize cost effective treatments to pavement sections that will deliver the best performance for the funds allocated. Simply put, a pavement management system saves public funds. An example of a PMP is shown in Figure 11.

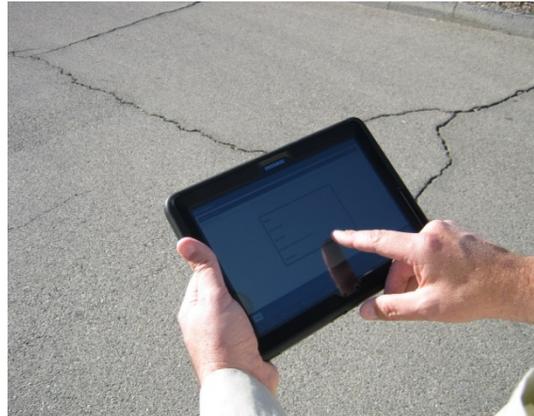
Inspection of pavement conditions is performed every year on one-fourth of the County's pavement network, which places all roads on a four-year inspection cycle. A field inspection or visual inspection survey is conducted by pavement raters (two-man crew) who walk each individual road segment evaluating the pavement for signs of distresses. In early 2012, the County switched its data collection approach from paper inspection sheets to a hand-held computer device, as depicted in Figure 12. Not only does a hand-held device accelerate the collection of pavement distress data, but it also reduces paper usage - an environmentally friendly methodology.

Figure 12. Tablet device use in road inspection.

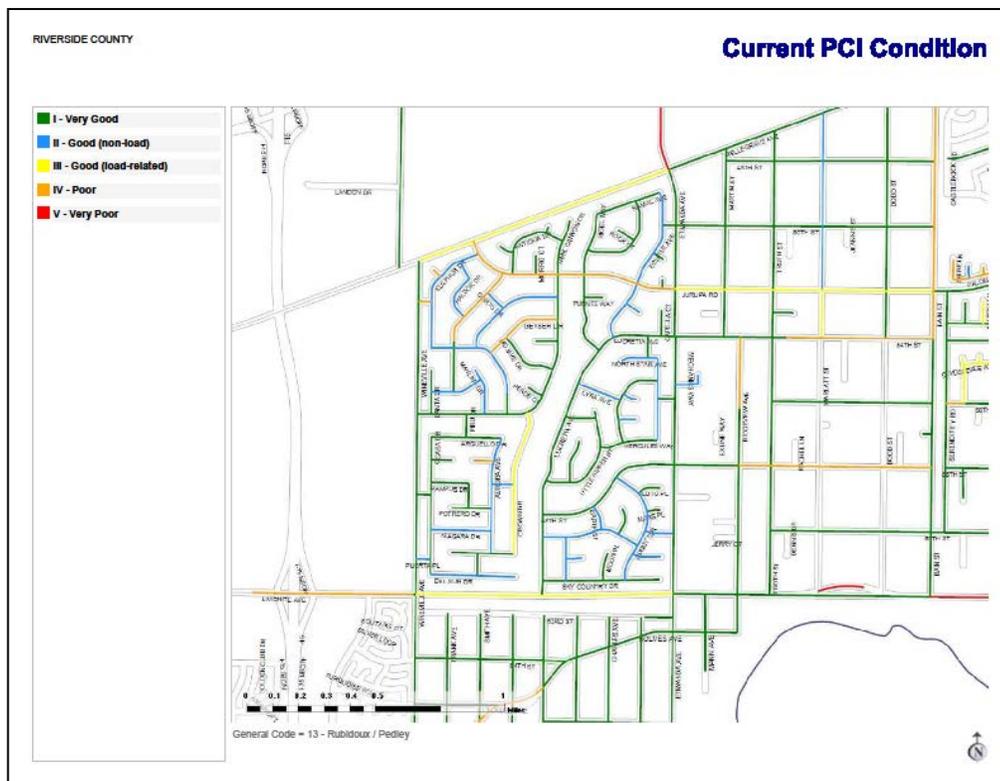
Figure 13. PMP result on GIS map.

The integration of the PMP with Geographic Information Systems (GIS) has provided the County a snapshot of the roadway network to better organize the data collected and facilitates in the decision-making in selecting roads to be included for treatment/repair in the upcoming fiscal year. An example of the PMP/GIS integration is shown in Figure 13.

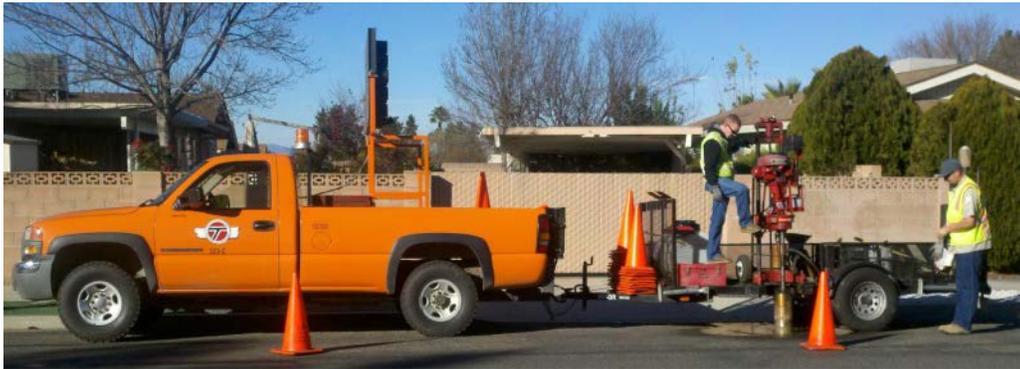
Figure 14. County's Coring Rig

The County invests millions of dollars each year in pavement maintenance activities. Records of performance of the pavement maintenance treatments placed during these activities are crucial in order to determine which treatment alternative is the best option to use. With advancements in data collection practices and equipment, the County invested in a Ground Penetrating Radar (GPR) and a Falling Weight Deflectometer (FWD) in addition to its already established data collection methodology of using coring and visual inspection survey. Figure 14 and Figure 15 depict the road data collection equipment.

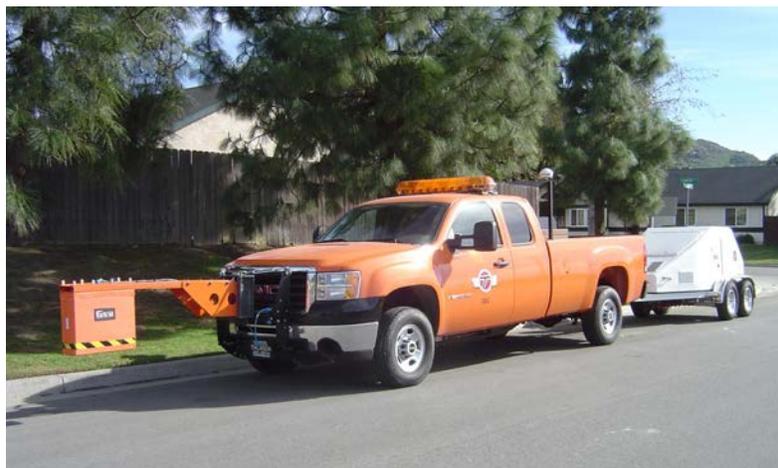
Figure 15. FWD and GPR Data Collection Equipment

The GPR is used to measure pavement layer thickness and detect groundwater or voids beneath the pavement. The FWD characterizes pavement structural condition. Data collected from this state of the art equipment provide new information that can be used to improve pavement management recommendations as well as support the County's pavement rehabilitation and design activities.

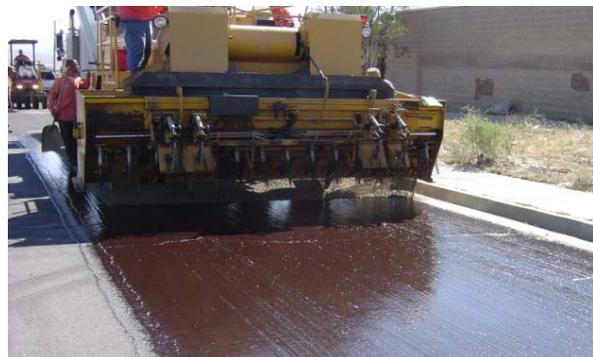
A chip seal is a surface treatment applied to pavement with minimal surface distress to provide a new wearing surface, extend pavement life, and delay major rehabilitation or reconstruction. It is a process in which an asphalt emulsion is sprayed on the pavement then immediately covered by aggregate. Figure 16 illustrates the spreading of aggregate over the sprayed emulsion.

Figure 16. Spreading of chip over emulsion.

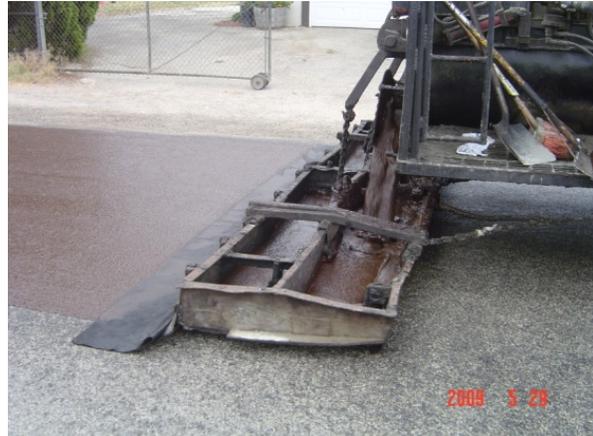
A slurry seal is a maintenance treatment applied to pavement to improve the functional characteristics of the pavement surface. It is a mixture of asphalt emulsion, aggregates and mineral fillers, which is mixed and placed in a continuous basis using a truck mixer. Prior to application, any surface distresses, such as cracks, are filled and sealed. After thoroughly mixing the emulsion, aggregates and mineral fillers in the slurry truck's built-in pug mill, the slurry mixture is poured into a spreader box. As the truck moves forward, the slurry is extruded from the backside of the spreader box, see Figure 17. The box is capable of spreading the slurry over the width of a traffic lane in a single pass resulting in a uniform application. The slurry cures as the water evaporates and turns the freshly placed brown slurry into black slurry. Traffic can be returned once the slurry has cured, which is usually four to six hours.

Figure 17. Spreading of slurry.

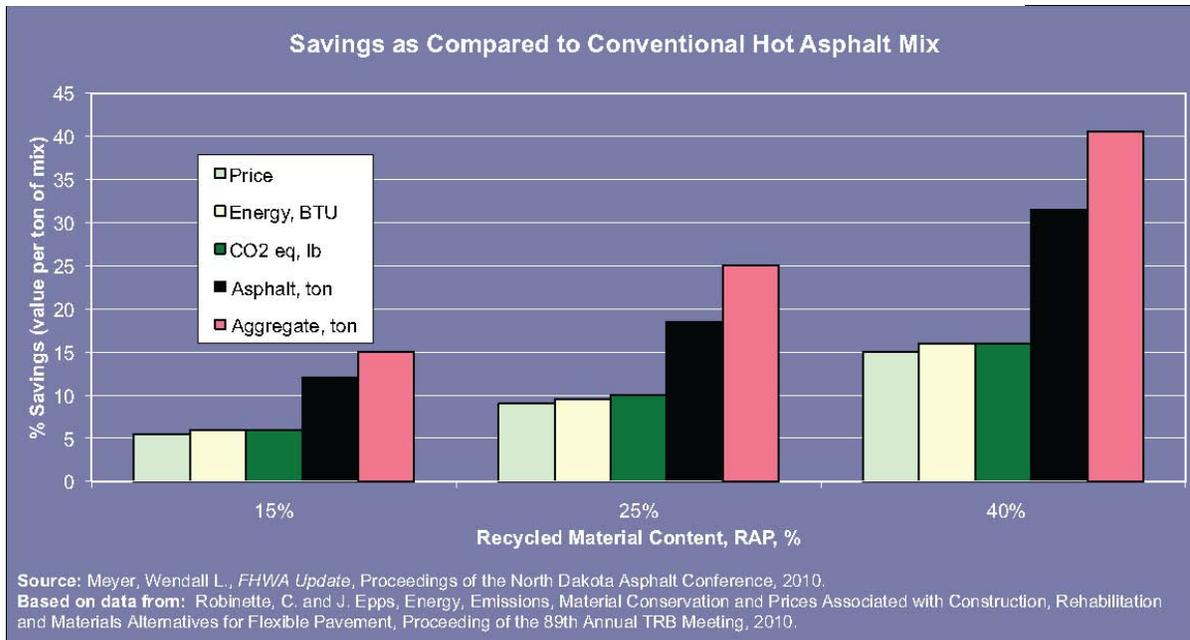
Figure 18. Benefits and Cost Savings of using RAP.

From the chart illustrated in Figure 18, some environmental benefits and cost savings of using at least 15 percent RAP in conventional HMA will yield a reduction in asphalt by about 12%, a decrease of virgin aggregate by about 15%, and a reduction of greenhouse gas emissions at a rate of 5 pounds per ton of RAP used in the hot mix asphalt.

Price corresponds to materials, construction, rehabilitation, and maintenance costs based on Life Cycle Cost Analysis (LCCA) with environmental impact assessment. Energy (BTU) represents the requirements for construction materials processing and construction material production. CO2 eq (lb) is a measure of greenhouse emissions and it includes the production of raw materials, transportation, production and laydown of materials. Asphalt and Aggregate in tons are considered the natural resources. [Sources: Transportation Research Board and Federal Highway Administration (FHWA)].
